River Habitat Survey (RHS) and Plant Community surveys of the River Wye SAC (Wales)

Report No: 849

Author Name: Julie Bywater, Bywater Ecology

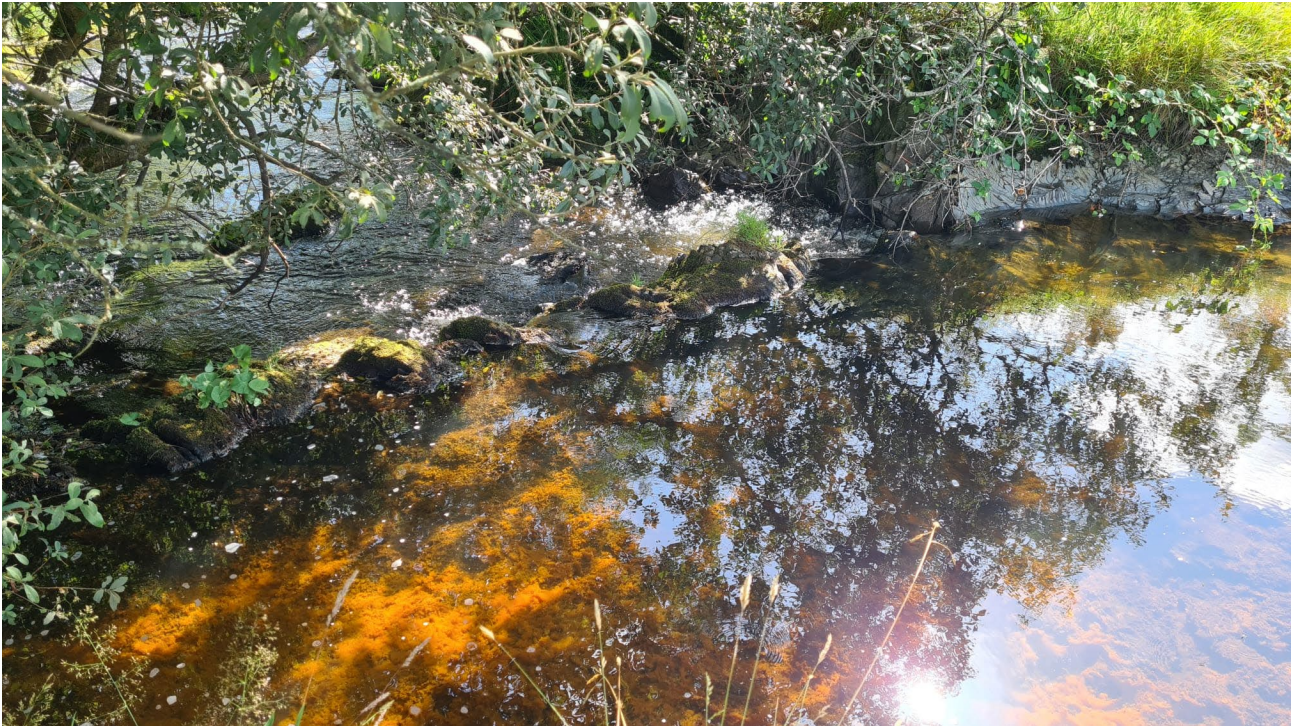
There was less than 0.1 % cover of filamentous algae, and iron bacteria were observed in the downstream section of the survey (figure 4).

Figure 4. Photo of Afon Bidno of iron bacteria observed downstream

Corridor Section (ECS) Score was 3, the middle category. Reprofiling of previously re-sectioned banks to a more natural profile or allowing them to degrade where it is safe to do so, is recommended.
