Llyn Tegid Reservoir Safety Project

Phase 1 Habitat Survey Report for additional site areas and validation

September 2019

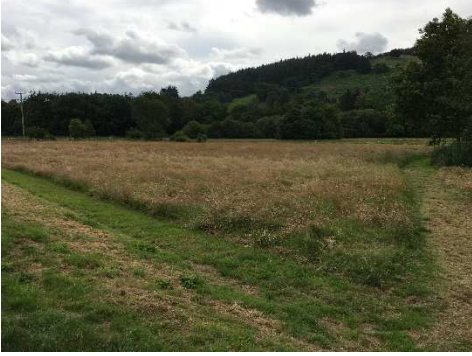
<p>Grassland area currently being used as meadow habitat. Grassland dominated by Yorkshire fog and common bent grasses. Mixed within the grassland was occasional greater birdsfoot trefoil <i>Lotus pedunculatus</i>.</p>
TN 14

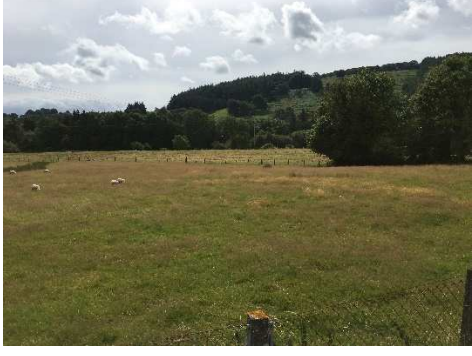
<p>Improved neutral grassland habitat that is currently being grazed by sheep. More diversity of grasses in these fields compared to others, including species such as common bent, Yorkshire fog, sweet vernal grass <i>Anthoxanthum odoratum</i>, crested dogstail <i>Cynosurus cristatus</i> and scattered creeping buttercup.</p>
TN 15

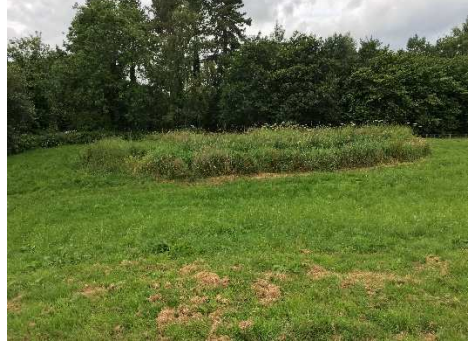
<p>Small pond at time of survey was dry. Vegetation dominated by common reed <i>Phragmites australis</i> and reedmace <i>Typha latifolia</i>. The remainder of the vegetation contained bramble and dominant common nettles.</p>
