River Habitat Survey (RHS) and Plant Community surveys of the River Wye SAC (Wales)

Report No: 849

Author Name: Julie Bywater, Bywater Ecology

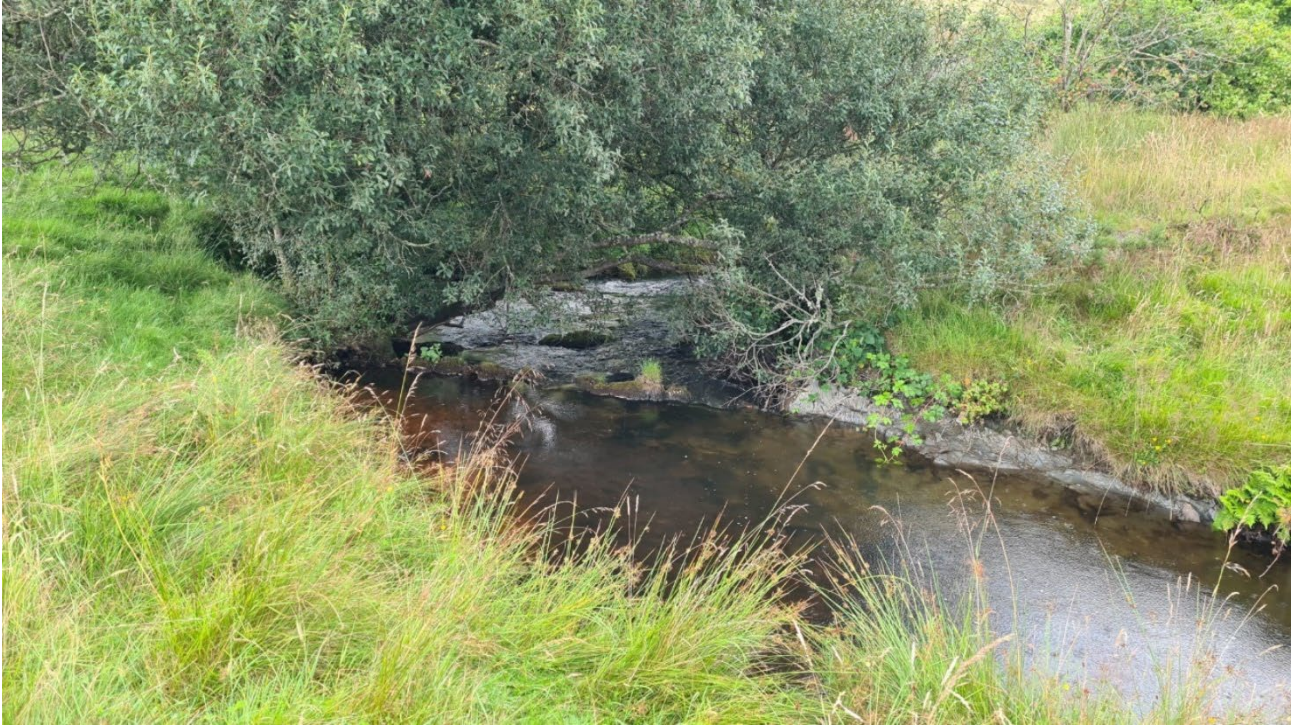
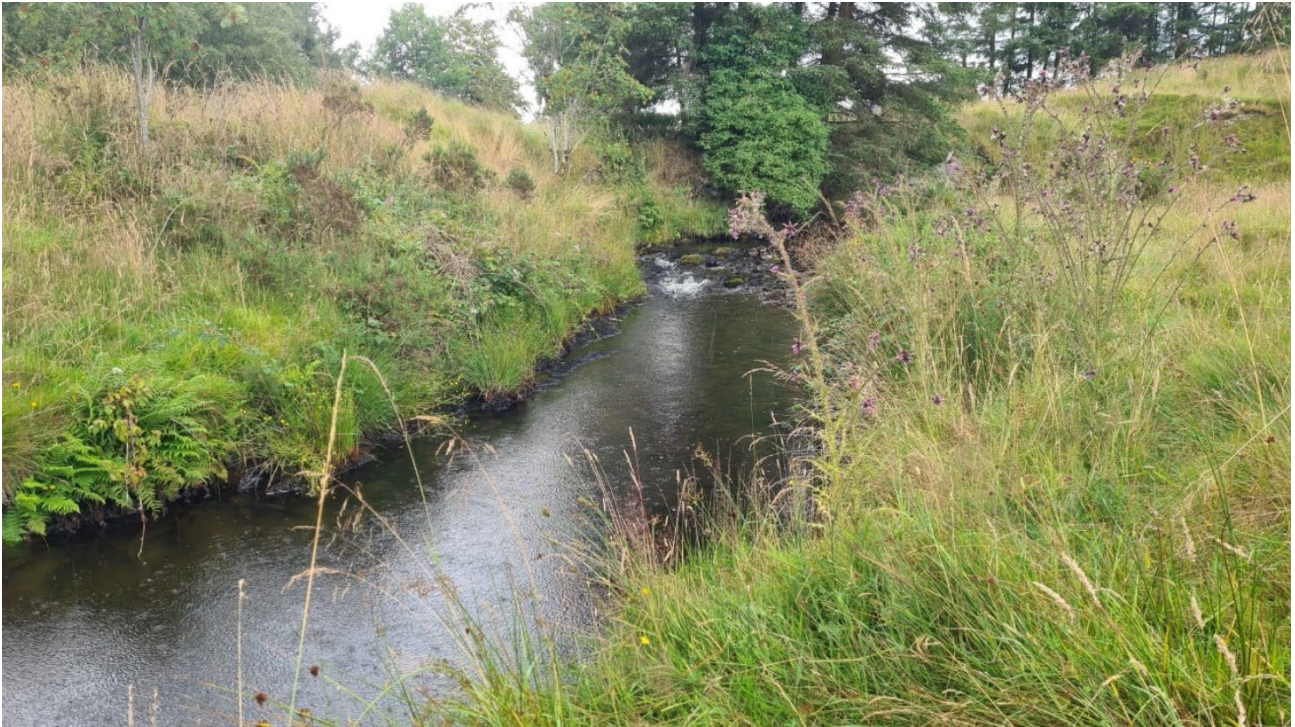
In the 500 m River Habitat Survey length, the predominant valley form was asymmetric floodplain with a distinct flat valley bottom. In the downstream section, there was historic re-sectioning noted with the right bank having a trapezoidal profile with no trees on the bank top for some of the length, and regularly spaced trees of similar species and size in the remaining. The left bank was steep and wooded in this location. The channel was deep compared to the width, but the bed was bedrock so had not been dredged. There were a number of 'kiddies weirs', where rocks had been placed across the channel, which had collapsed and were not holding the water back, so these were recorded as groynes. Further high flows would likely see these demolished and improve the habitat modification score, which was class 3, due to the presence of bridges and localised reinforced and re-sectioned banks.

Figure 2. Photo of Afon Bidno at the midpoint facing upstream

Figure 3. Photo of Afon Bidno at the midpoint facing downstream

Corridor Section (ECS) Score was 3, the middle category. Reprofiling of previously re-sectioned banks to a more natural profile or allowing them to degrade where it is safe to do so, is recommended.

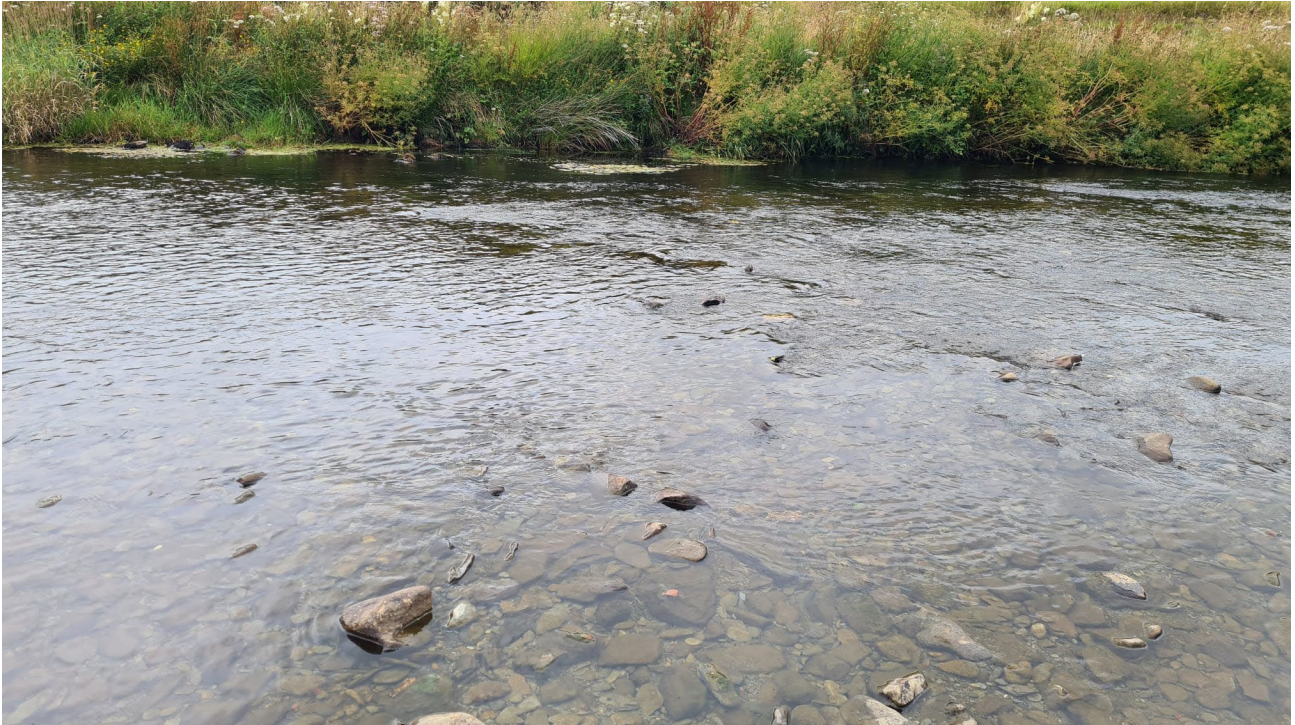
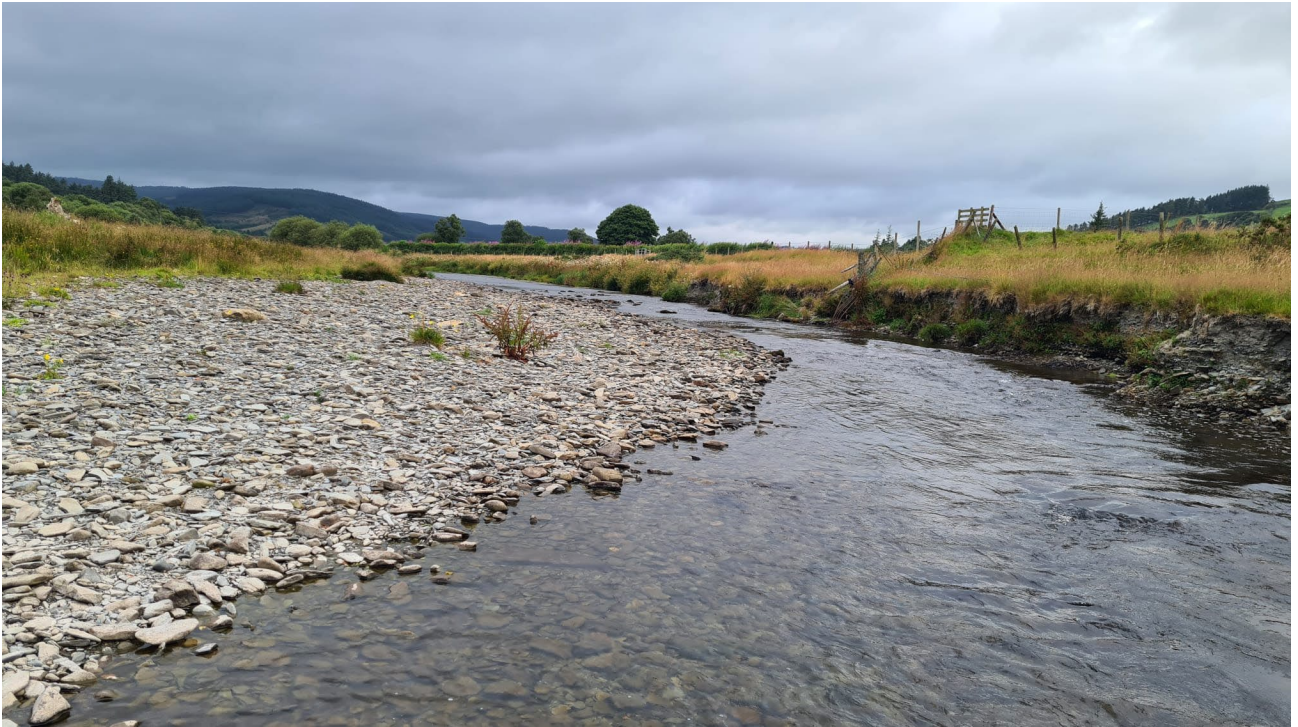
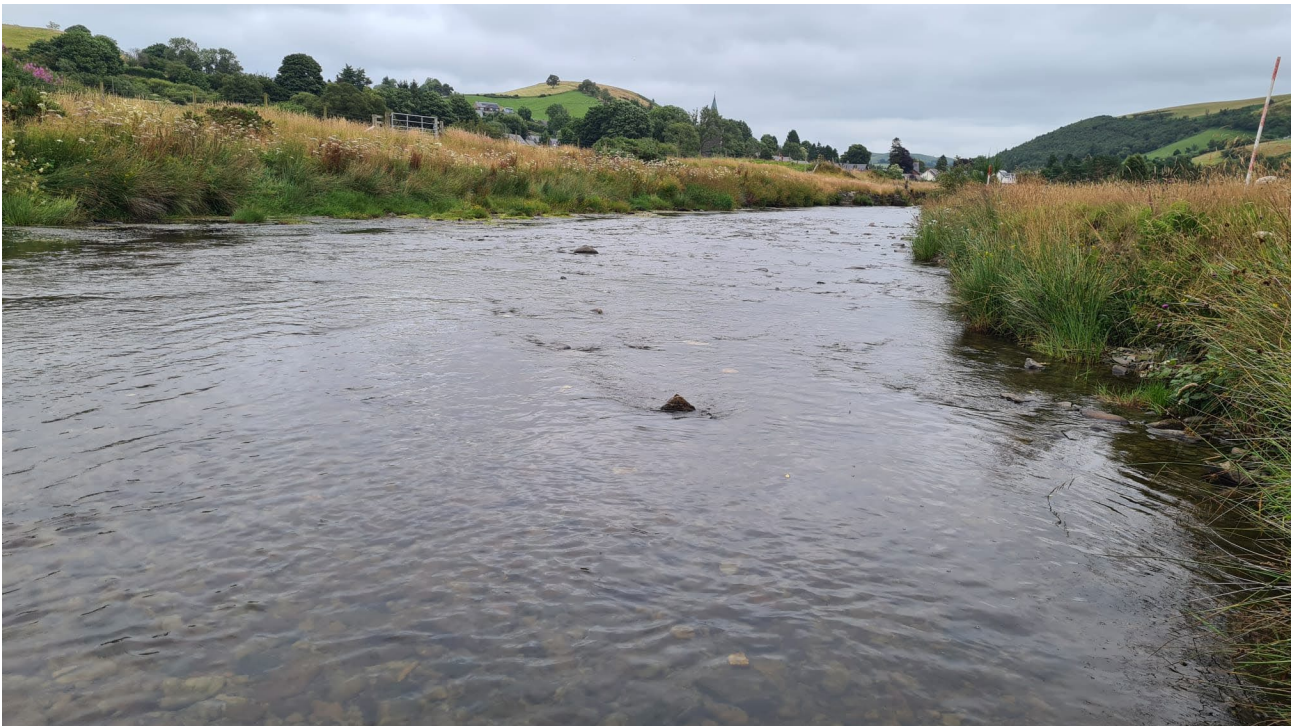
In the 100 m macrophyte survey length, the river channel was approximately 18 m wide at the midpoint with a predominantly cobble and gravel/pebble substrate. There was a large side bar along approximately half the right bank, extending halfway across the channel for most of the length, with the water only 4 m wide at the downstream end of the survey length. There was no obvious sediment on the riverbed and the water was clear. There was no shading of either bank. An embanked area noted in the 2012 macrophyte survey was no longer present due to erosion of the bank.

Figure 5. Photo of Wye at Llangurig at the midpoint across the channel

Figure 6. Photo of Wye at Llangurig at the midpoint facing upstream

Figure 7. Photo of Wye at Llangurig at the midpoint facing downstream

knapweed (*Centaurea nigra*) and tufted hairgrass (*Deschampsia cespitosa*), whilst the right bank was mainly grassland. The surrounding land was used for sheep grazing. The Evaluated Corridor Section (ECS) Score was 4, the second highest category. It is recommended that fencing on the left bank is moved back from the bank top to allow colonisation of the banks by native flora where there has been historic re-sectioning and the bank is eroding, to create a buffer to disturbance and diffuse pollution.

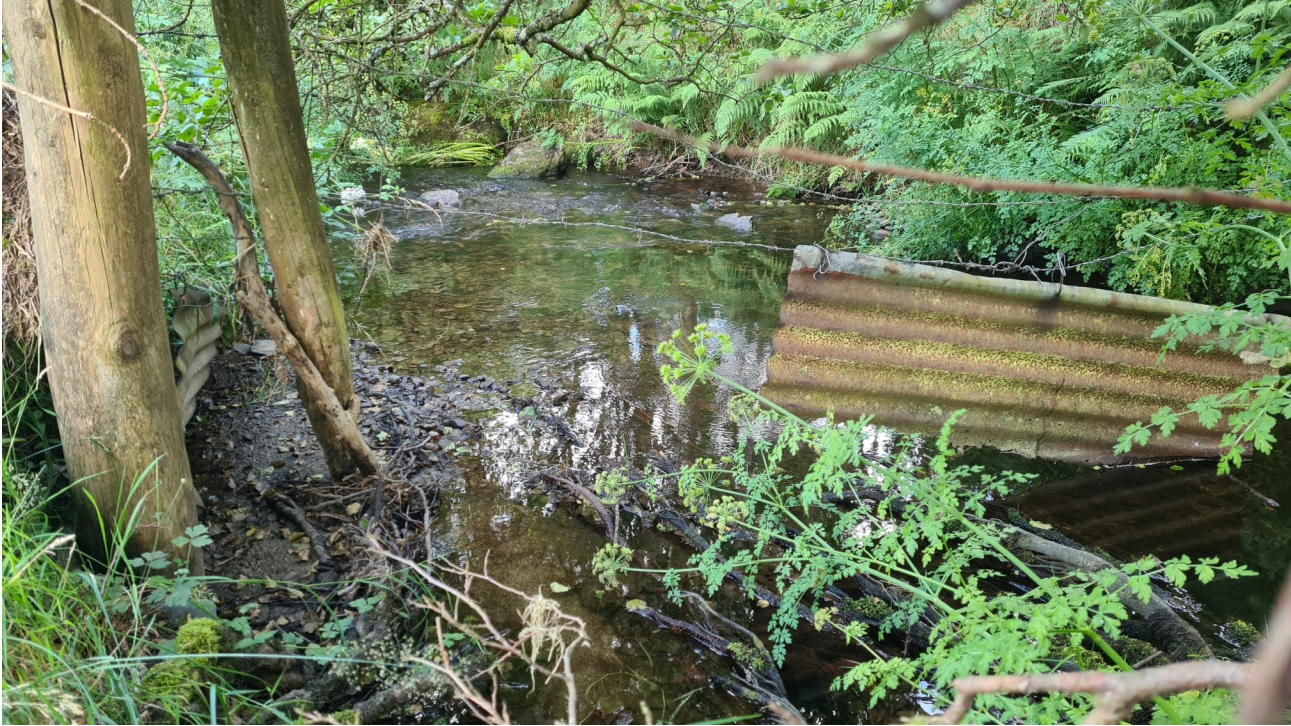
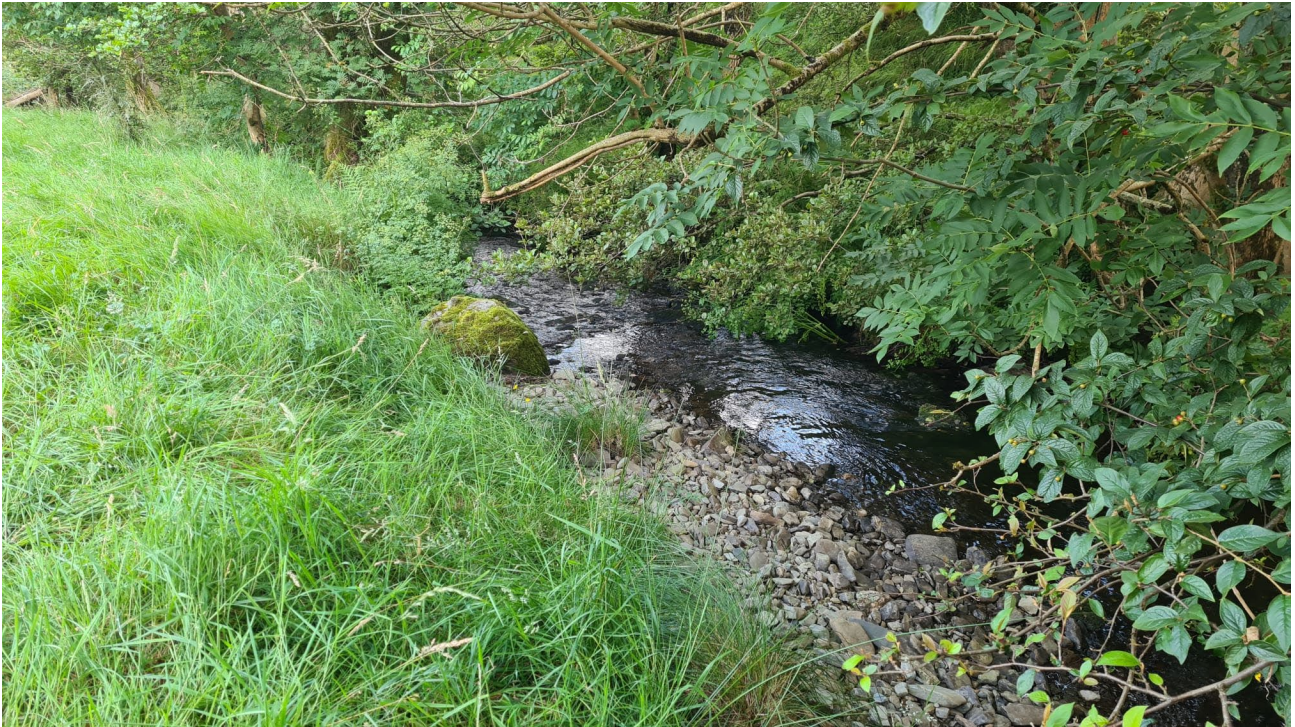
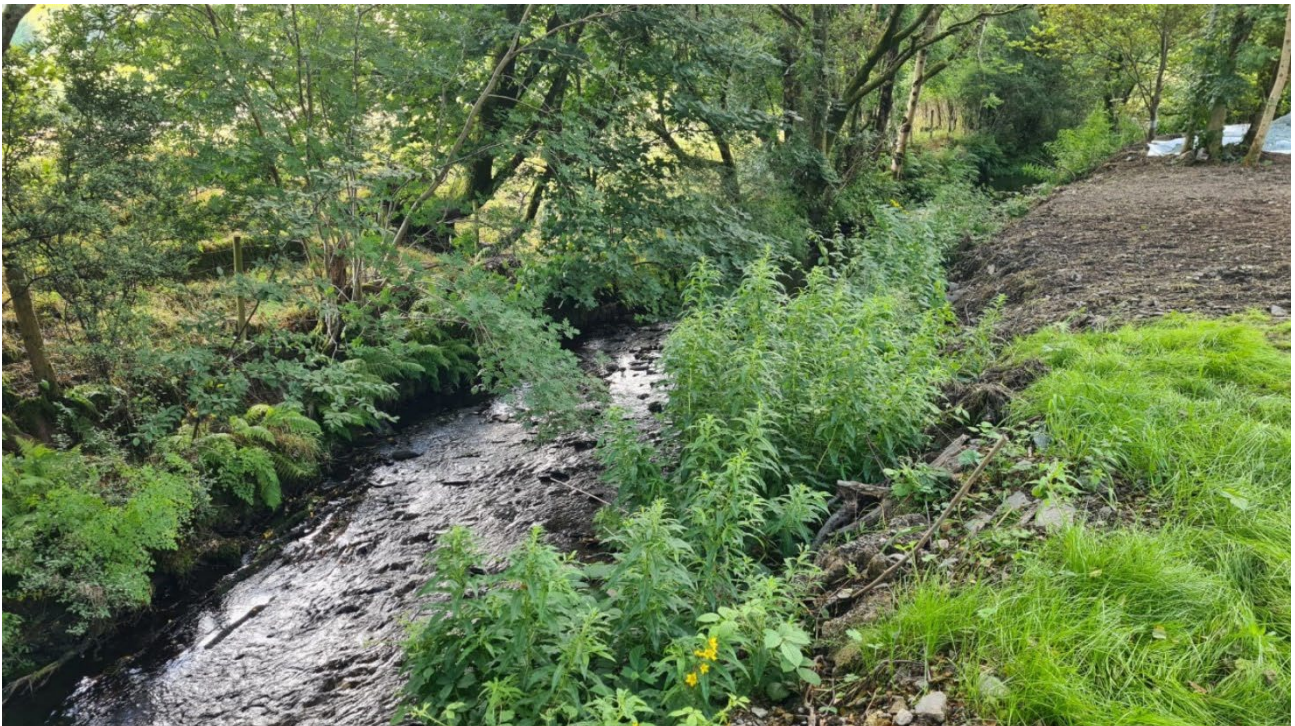
This site was impacted by agricultural use with low quality grassland on the bank tops, and by urban encroachment with a road running alongside the left bank, and local residents creating parking spaces on the bank top and dumping garden waste in the river corridor. The original site midpoint had high banks that were eroding, possibly due to confinement of the channel within the banks.

Figure 8. Photo of Nant y Dernol at the midpoint across the channel

Figure 9. Photo of Nant y Dernol at the midpoint facing upstream

Figure 10. Photo of Nant y Dernol at the midpoint facing downstream

Protection of the bank top vegetation is recommended where there is urban encroachment, with education of local residents to prevent unauthorised development and dumping of garden waste and enforcement where appropriate.

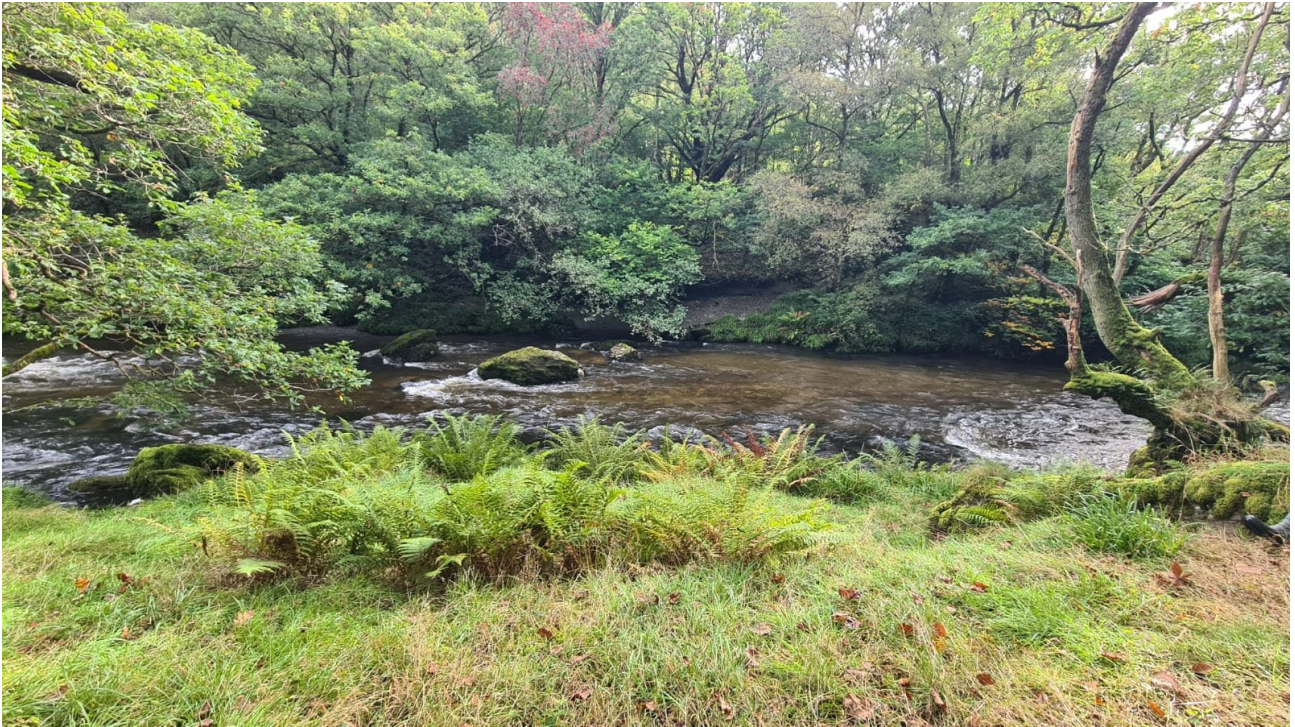
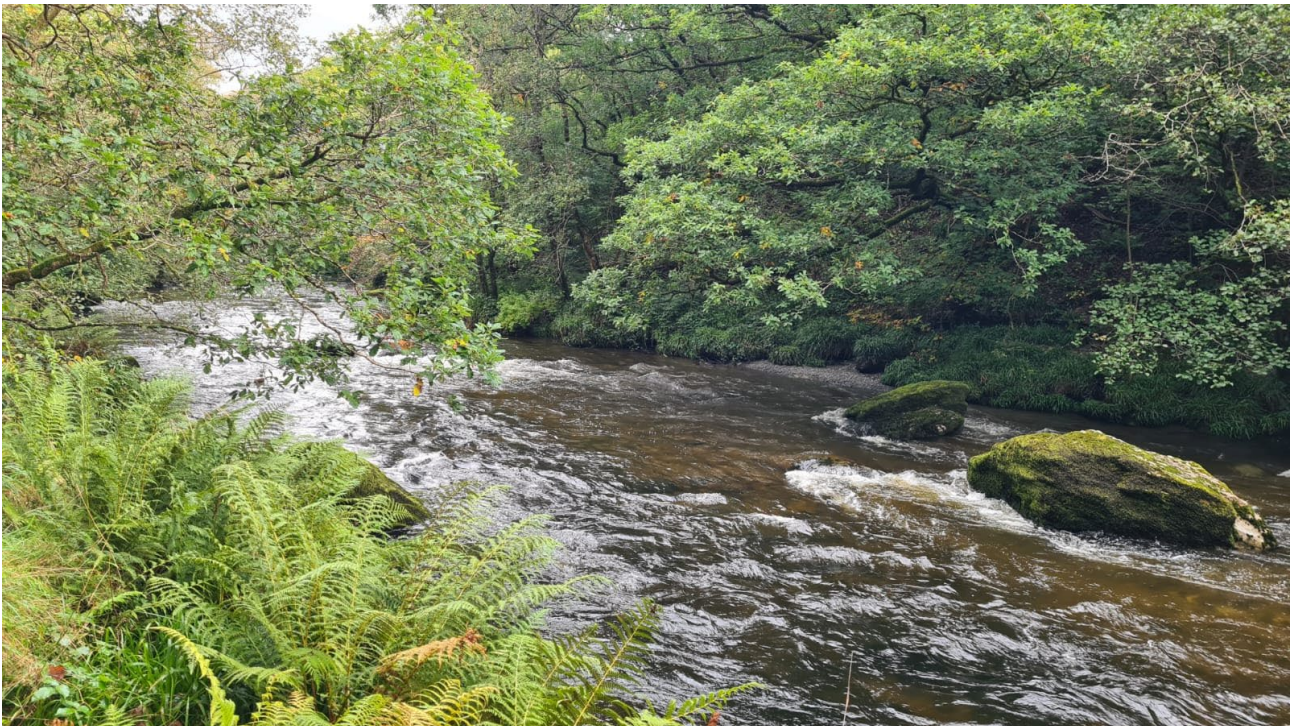
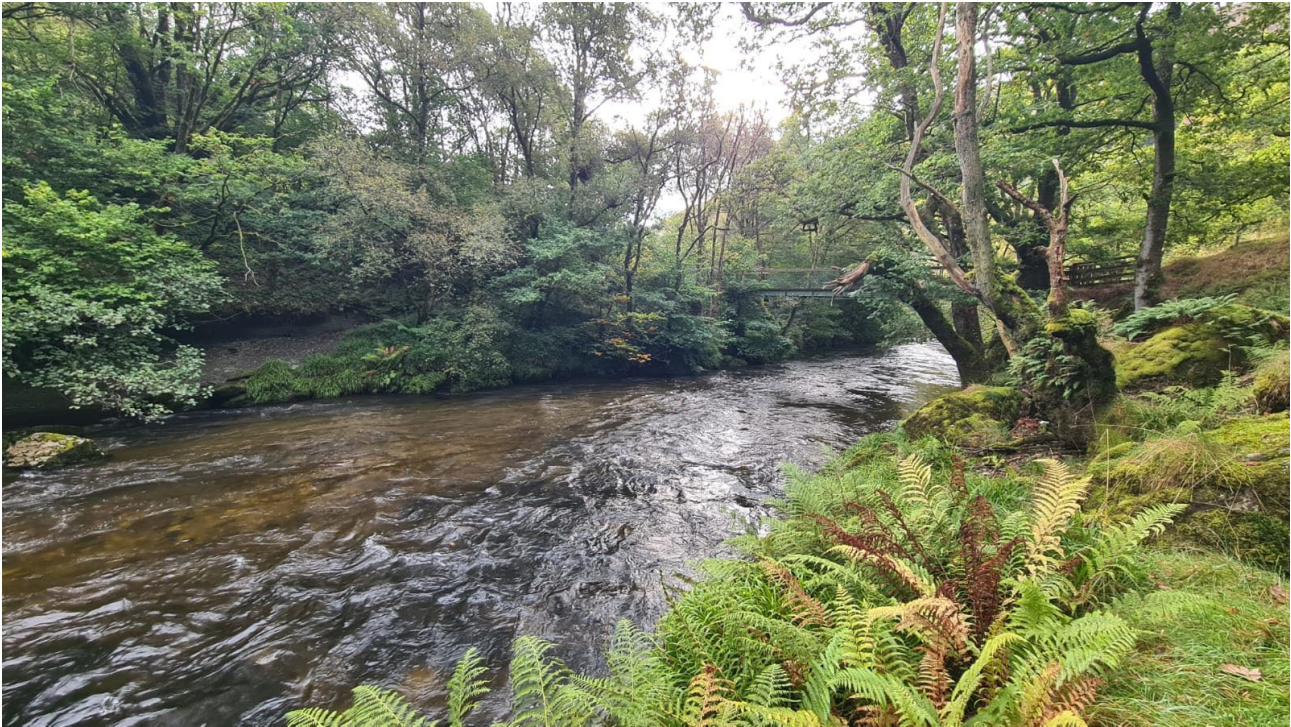
In the 500 m RHS, there were no bank modifications observed except for some bank poaching on both banks. There was a track along right bank face at the midpoint, but this was not included as re-sectioning as it was high above the water. In the downstream half of the RHS, the A470 runs alongside the bank top, but there was a band of woodland dominant. Elsewhere, the A470 crosses part way up the bank, but was not recorded as re-sectioned as it was high above the water. There were no artificial features other than a minor bridge which was high above the water spanning the channel and the HMS class was 2.

Figure 11. Photo of Wye, u/s of Marteg, at the midpoint across the channel

Figure 12. Photo of Wye, u/s of Marteg, at the midpoint facing upstream

Figure 13. Photo of Wye, u/s of Marteg, at the midpoint facing downstream

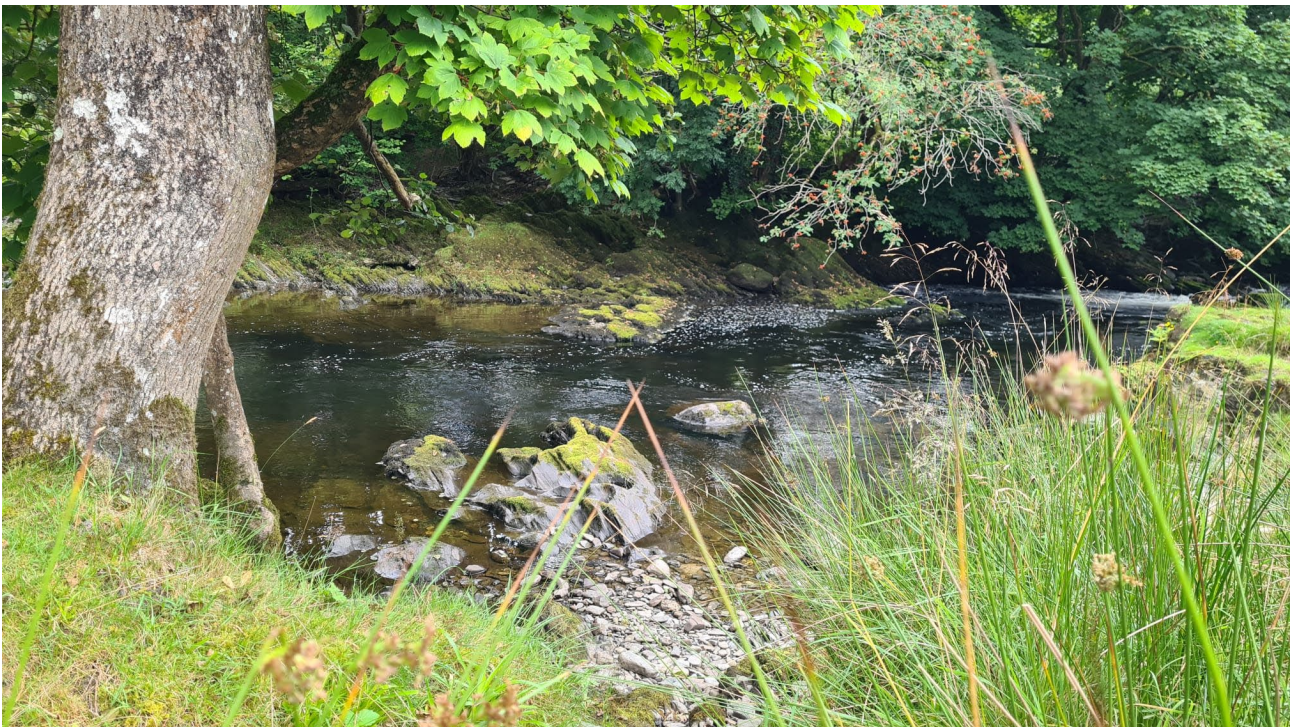
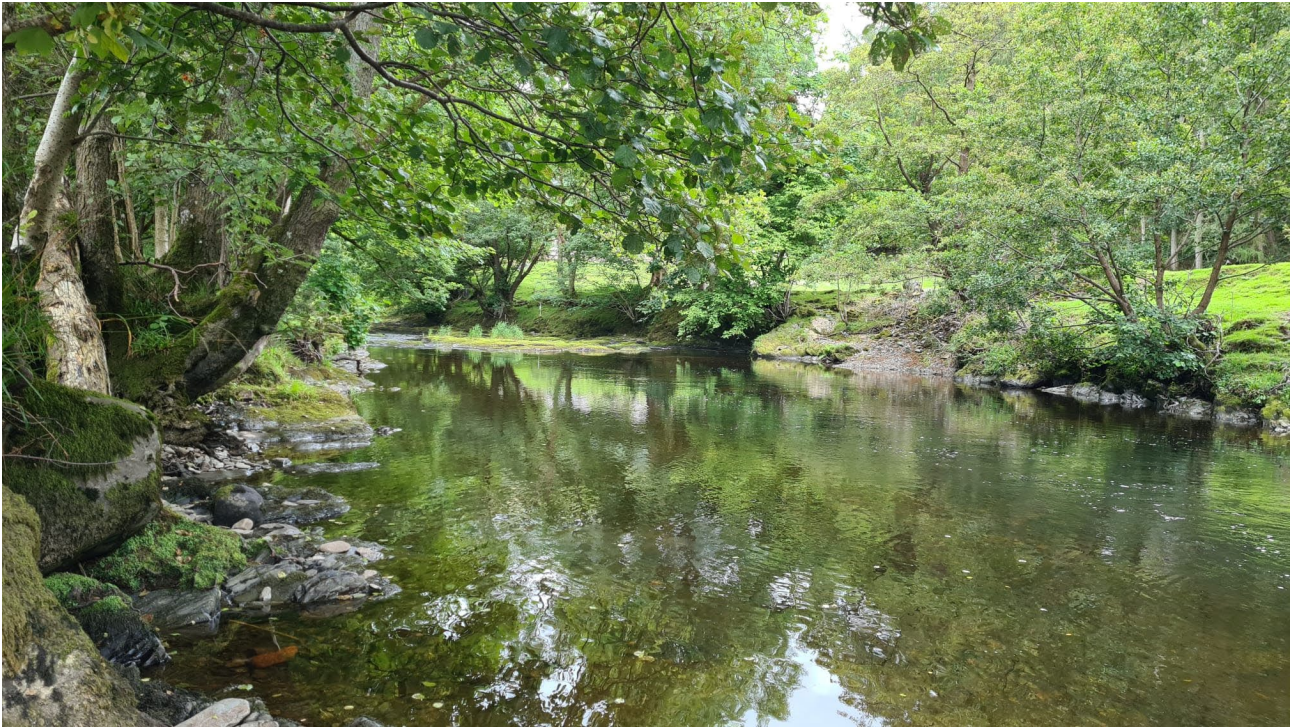
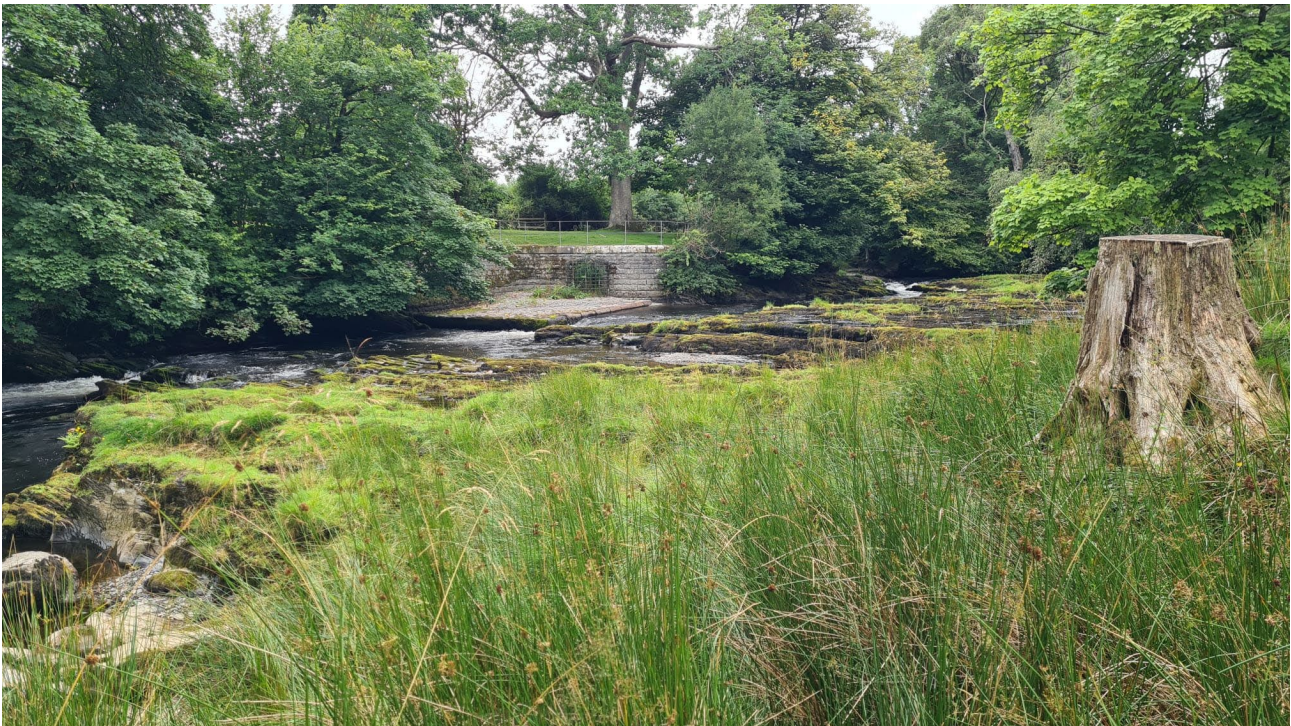
This site is therefore impacted by agricultural use, bank re-sectioning and reinforcement, possible sewage discharge resulting in epiphytic algae cover, and bank poaching. Reprofiling of previously re-sectioned banks to a more natural profile or allowing them to degrade where it is safe to do so, is recommended, along with fencing set back from the bank top to allow colonisation of the banks by native flora, creating a buffer to disturbance and diffuse pollution.

Figure 14. Photo of Wye, Rhayader, at the midpoint across the channel

Figure 15. Photo of Wye, Rhayader, at the midpoint facing upstream

Figure 16. Photo of Wye, Rhayader, at the midpoint facing downstream

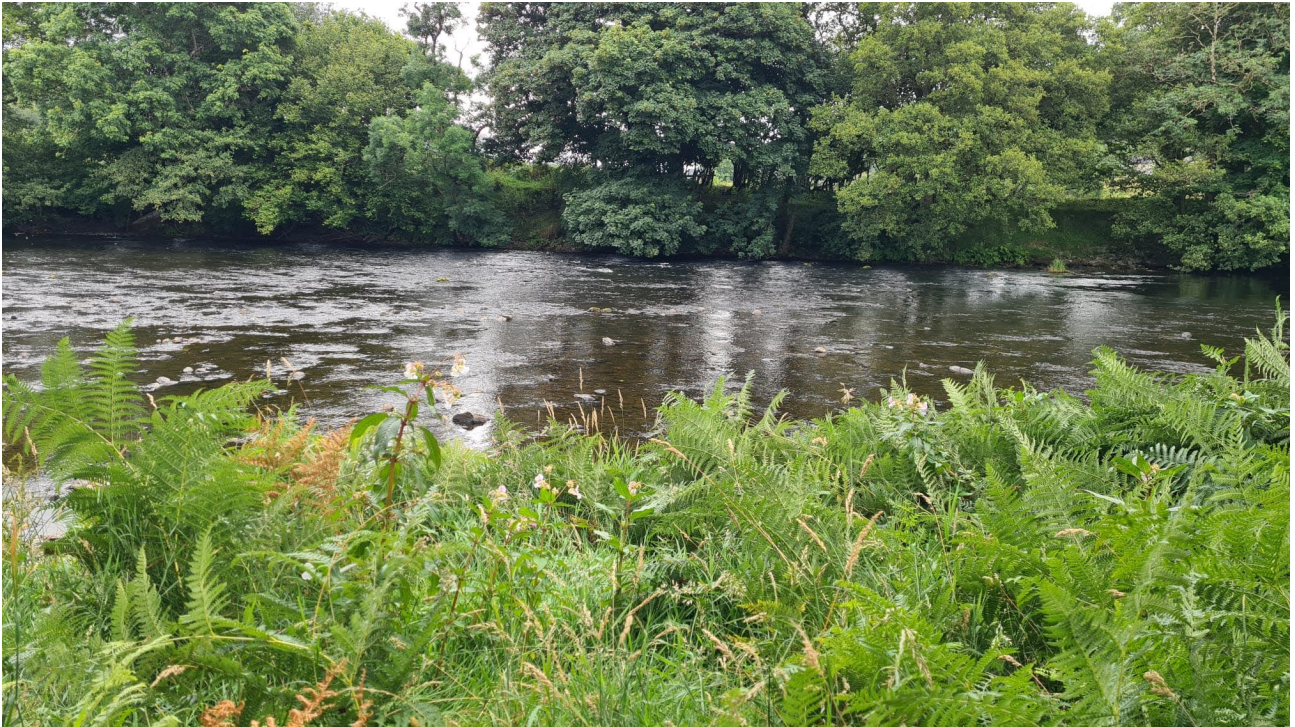
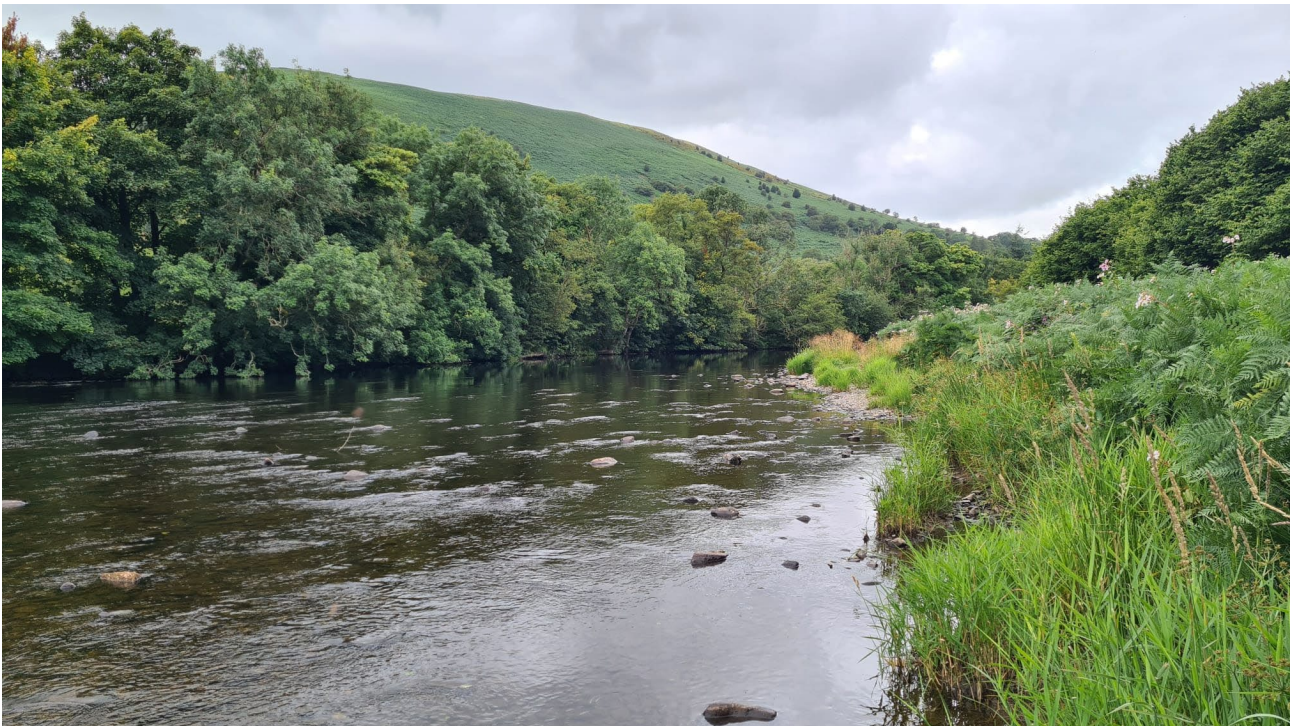
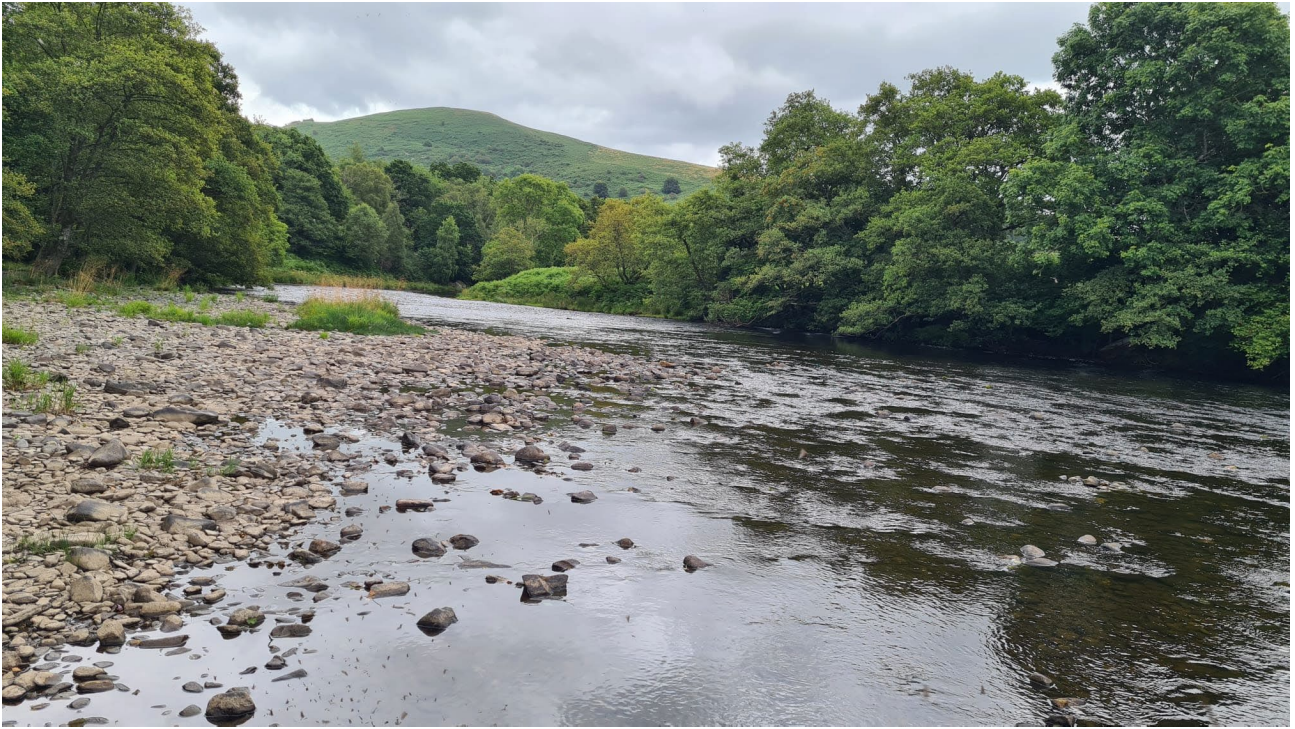
Himalayan balsam was extensive on both the bank face and the bank top in this survey, where INNS were not recorded at any other sites in the upper Wye catchment. The HMS was low being only 2, reflecting the lack of modification.

Figure 17. Photo of Wye, Treflyn, at the midpoint across the channel

Figure 18. Photo of Wye, Treflyn, at the midpoint facing upstream

Figure 19. Photo of Wye, Treflyn, at the midpoint facing downstream

In the Simplified Phase 1, both banks had trees on the bank faces and bank tops for much of the length so high scoring broad leaved woodland was the dominant habitat, but elsewhere was low scoring poor improved grassland or bracken. The surrounding land was used for sheep grazing. Control of invasive species, Himalayan balsam and bracken on the banks is recommended for this site, with possible water quality issues to investigate with epiphytic algal cover of rocks in the RHS survey, probably due to enrichment.

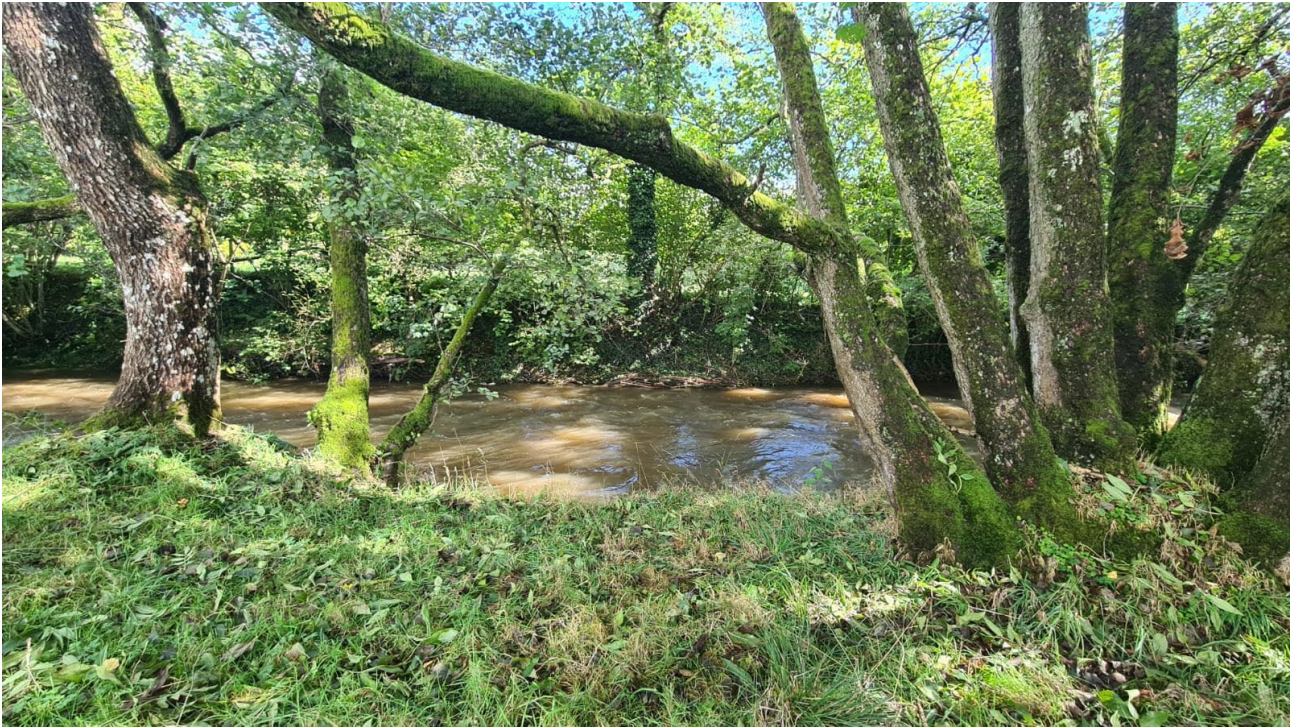
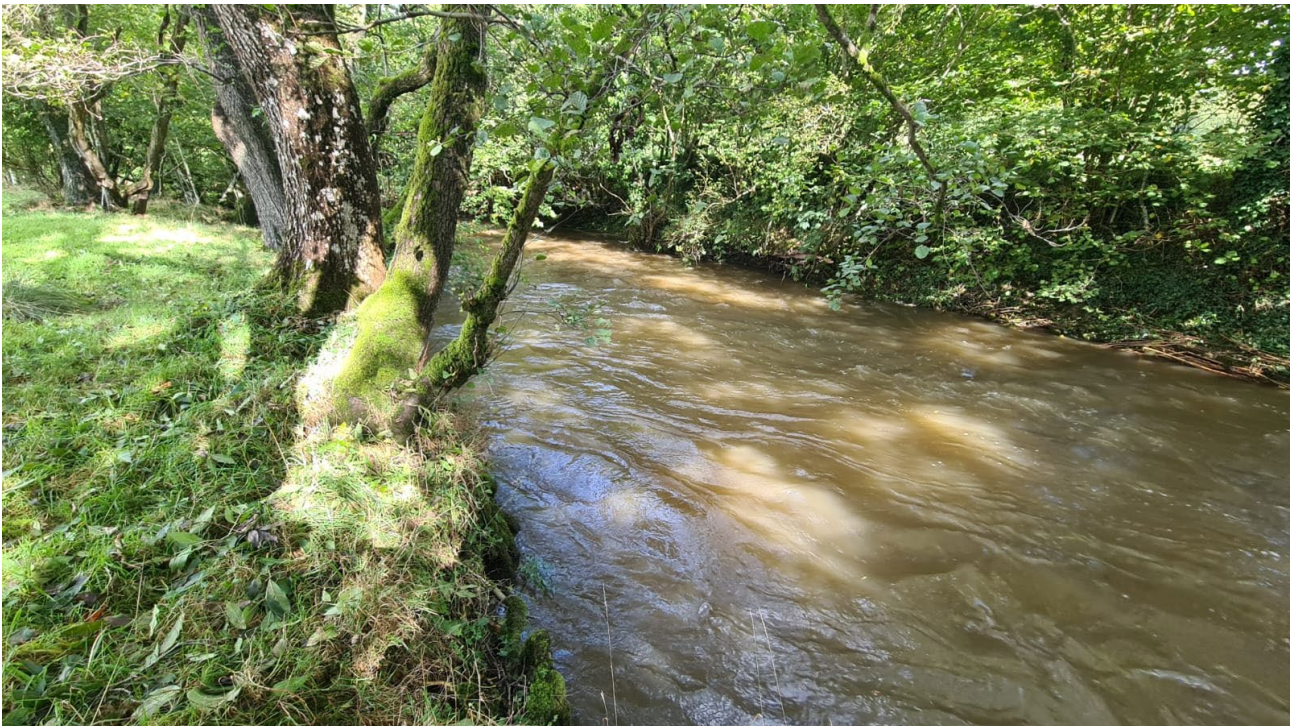
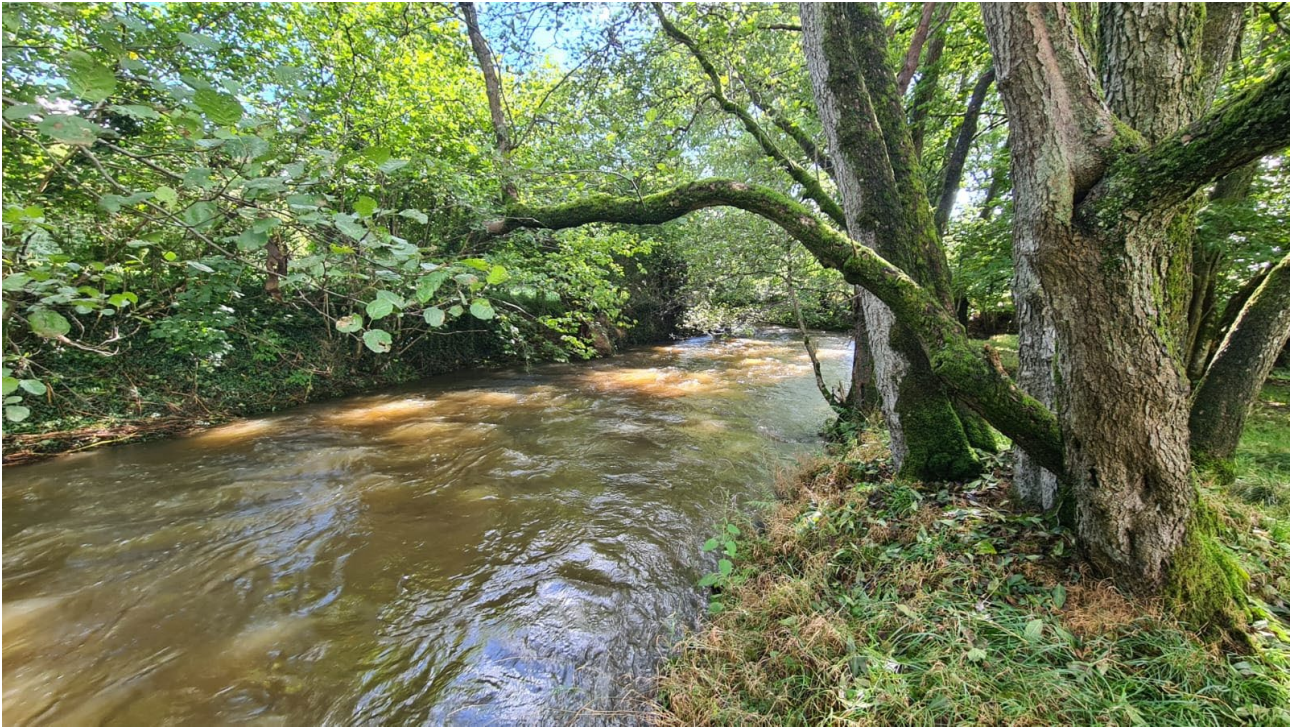
In the RHS, the left bank had no trees on the bank top and the profile was trapezoidal at the midpoint and upstream of that for 150 m, but mature trees were present on the bank face along with lots of young hazel trees. Trees mostly present on the bank faces in this survey length. This indicates that the bank had been modified, and so re-sectioning was recorded as extensive on the left bank. Poaching was present on both banks, but not extensive. There were two field drains emptying onto the right bank approximately 20 m from the water's edge creating wet marshy areas, and there was a minor bridge, but no other artificial features. At the downstream end of the survey, the river was fenced on both banks so was inaccessible. The HMS class was 3 due to the re-sectioning and poaching.

Figure 20. Photo of Clywedog, Brynlllygoed at the midpoint across the channel

Figure 21. Photo of Clywedog, Brynlllygoed at the midpoint facing upstream

Figure 22. Photo of Clywedog, Brynllgoed at the midpoint facing downstream

In the Simplified Phase 1, the Evaluated Corridor Section (ECS) Score was 5, the highest category, primarily because of the presence of unimproved and good semi-improved pasture and trees. Both banks had continuous trees on the bank faces and/or bank tops. The surrounding land was used for sheep grazing. Reprofiling of previously re-sectioned banks to a more natural profile, or allowing them to degrade where it is safe to do so, is recommended, along with movement of fencing away from the bank top in the downstream section of the RHS to allow a more natural vegetation to establish and create a buffer zone.
