River Habitat Survey (RHS) and Plant Community surveys of the River Wye SAC (Wales)

Report No: 849

Author Name: Julie Bywater, Bywater Ecology

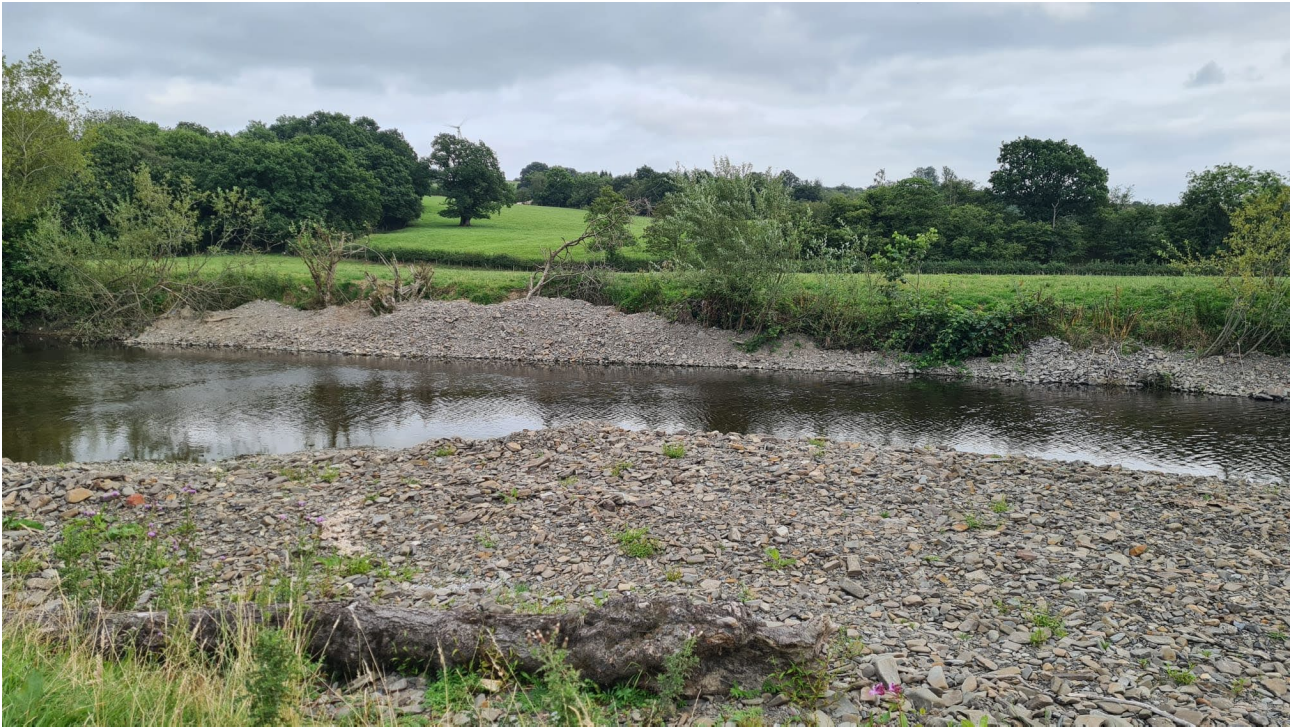
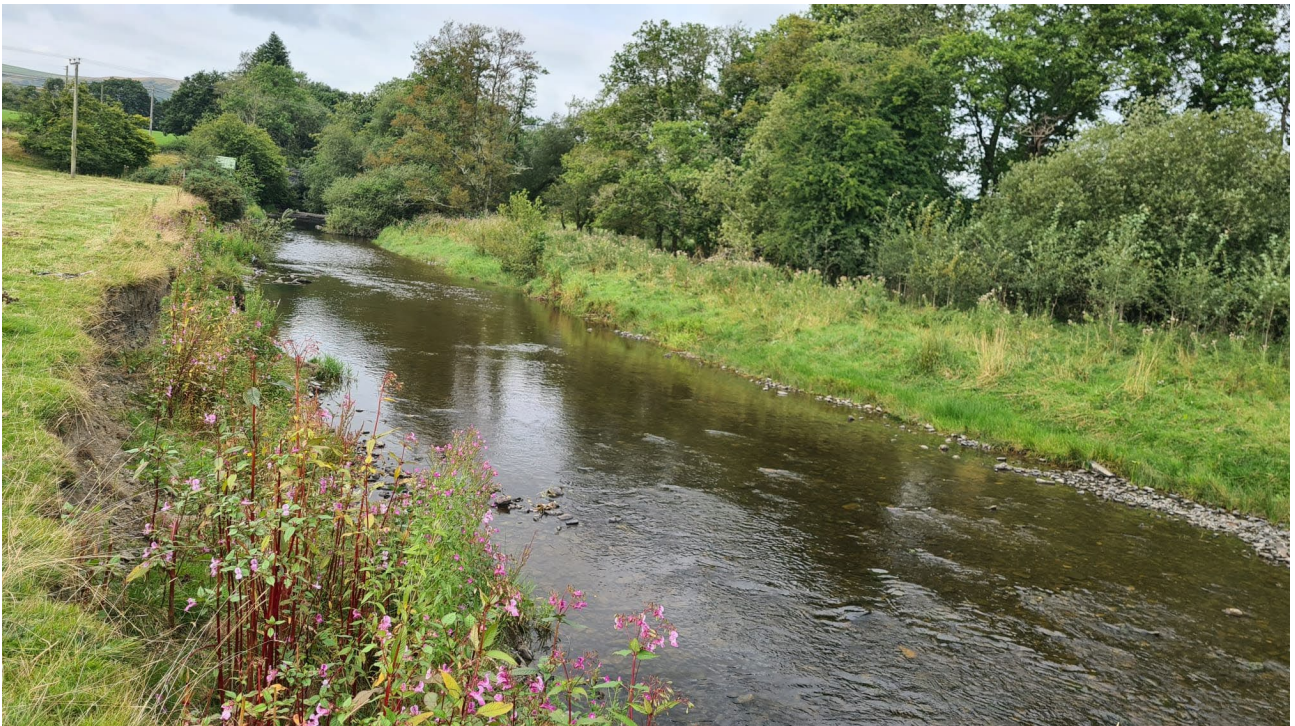
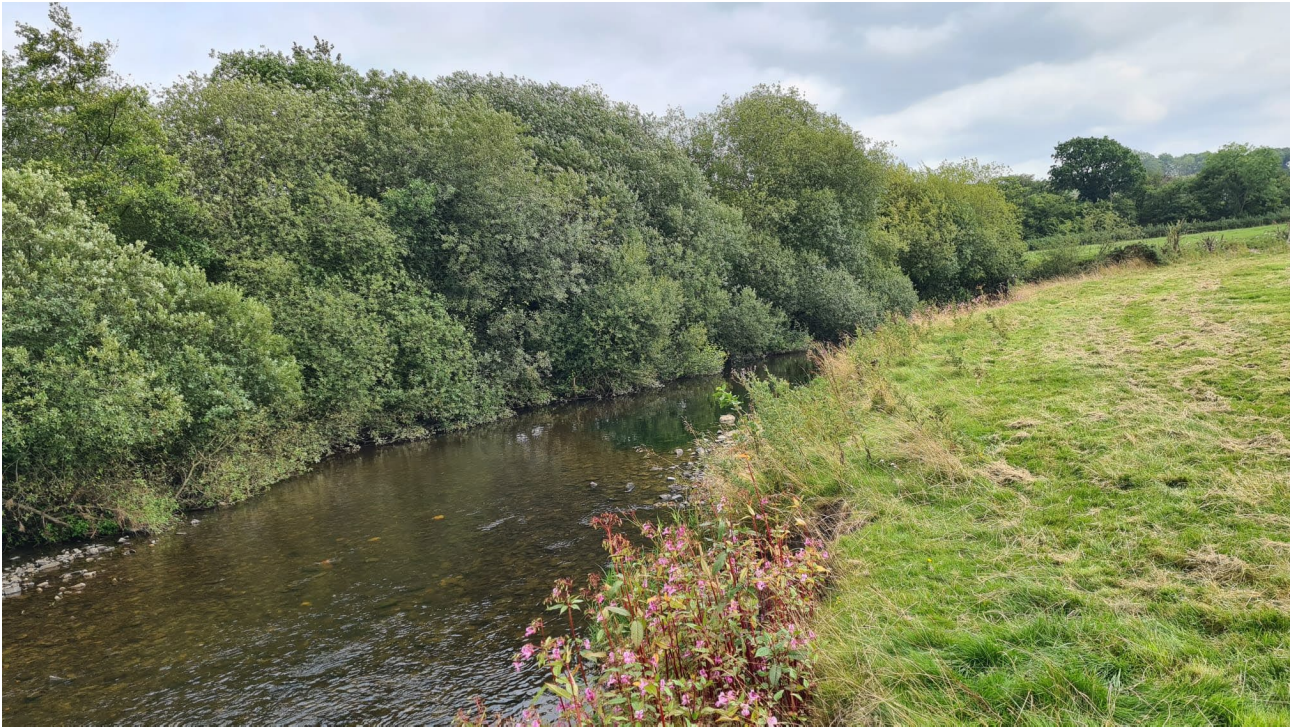
This site had an HMS class of 5, indicating a heavily modified site, mainly due to the re-sectioning at this site. Whilst this was mainly historic, and at other sites was not recorded as such due to the channel recovering, there was evidence of recent dredging at this site, and the trapezoidal bank profile was not degenerating.

Figure 23. Photo of Ithon, d/s A485 road bridge, at the midpoint across the channel

Figure 24. Photo of Ithon, d/s A485 road bridge, at the midpoint facing upstream

Figure 25. Photo of Ithon, d/s A485 road bridge, at the midpoint facing downstream

Low scoring poor semi-improved grassland dominated the simplified phase one survey, but the site attained a moderate score thanks to the presence of high scoring woodland. Any unauthorised alterations to the watercourse should be investigated and remediation measures put in place. Reprofilling of previously re-sectioned banks to a more natural profile or allowing them to degrade where it is safe to do so, is recommended. Control of the invasive Himalayan balsam is also recommended, and whilst poaching was not a particular issue at this site, the vegetation was grazed up to the bank top so fencing set away from the bank top would allow creation of a buffer strip.

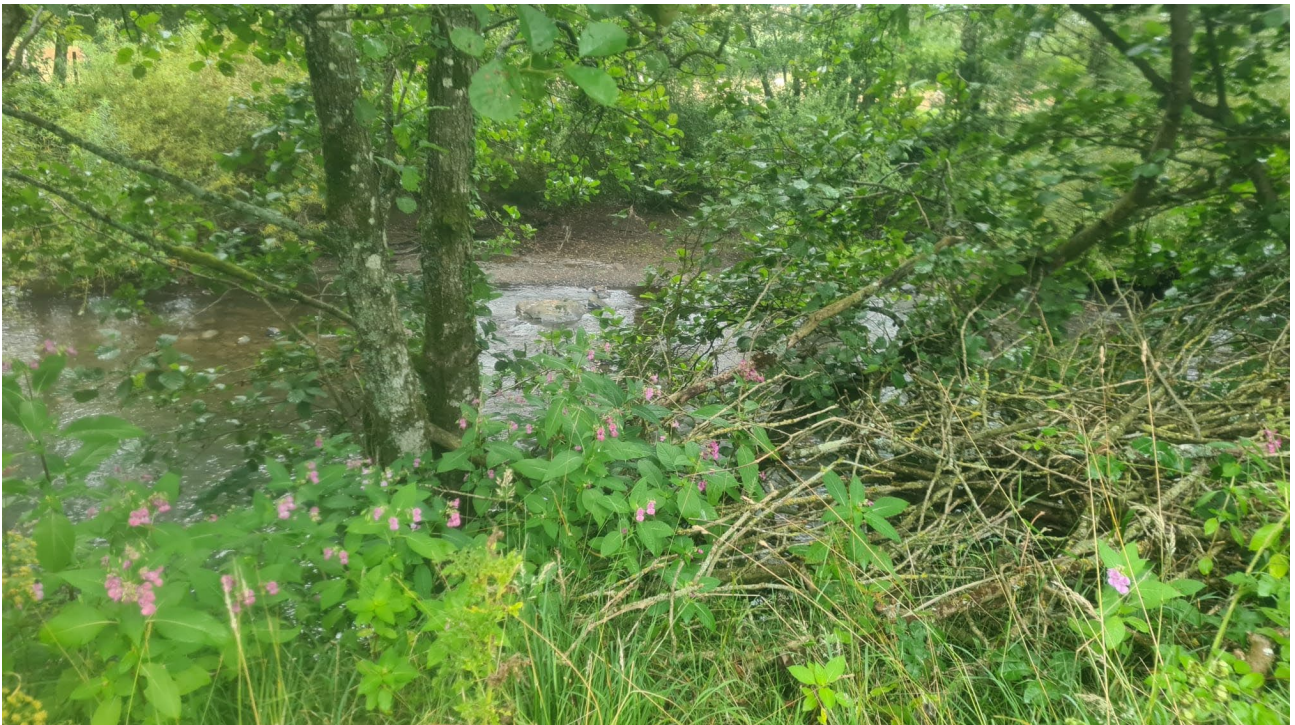
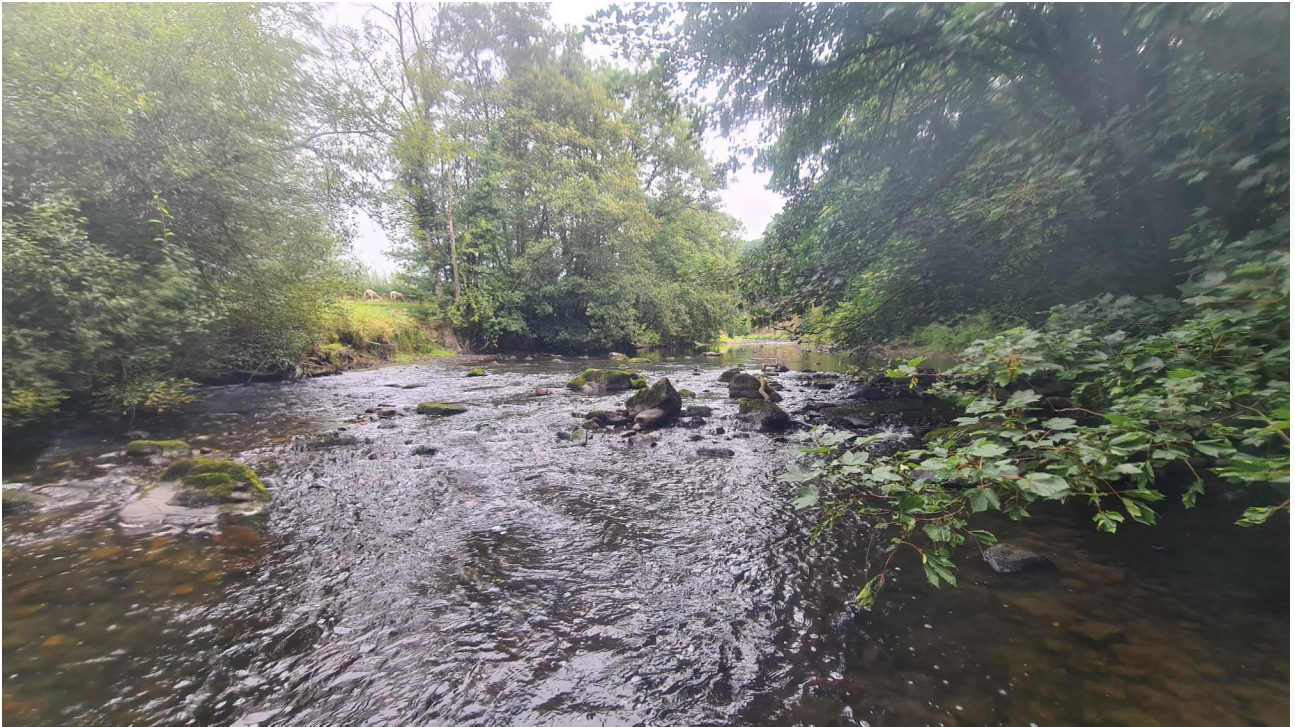
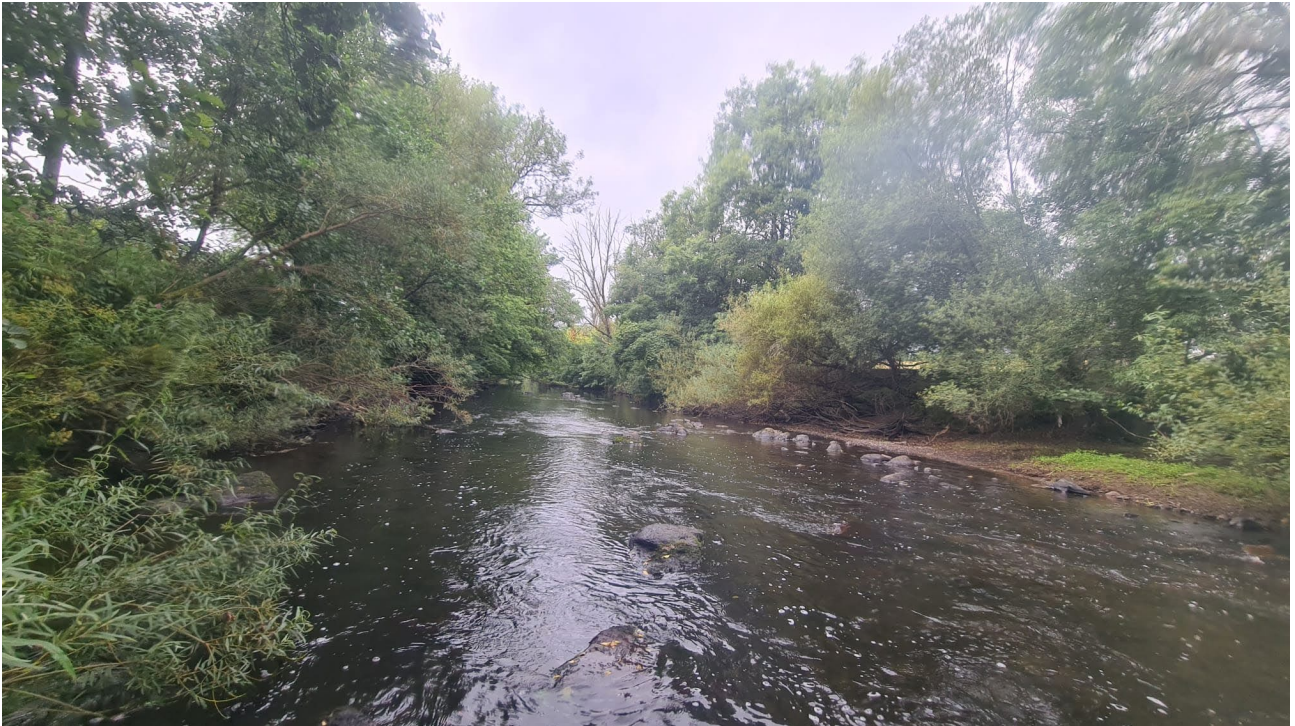
recorded as re-sectioned in the survey. Himalayan balsam was present on the bank face and extensive on the bank top. The HMS class was 2, as no artificial features were recorded, but the channel was noted as having possibly been realigned and over deepened.

Figure 26. Photo of Ithon, Dolberthog, at the midpoint across the channel

Figure 27. Photo of Ithon, Dolberthog, at the midpoint facing upstream

Figure 28. Photo of Ithon, Dolberthog, at the midpoint facing downstream

The surrounding land is used for grazing sheep, and whilst the presence of broad-leaved woodland meant the simplified phase one score was moderate, the high scoring unimproved pasture recorded in the upstream section on the right bank was a narrow strip with improved grassland beyond the bank top. Creation of a wider buffer strip along the bank top is recommended to enhance the quality of the channel and protect the water quality. Control of the invasive Himalayan balsam is also recommended at this site.

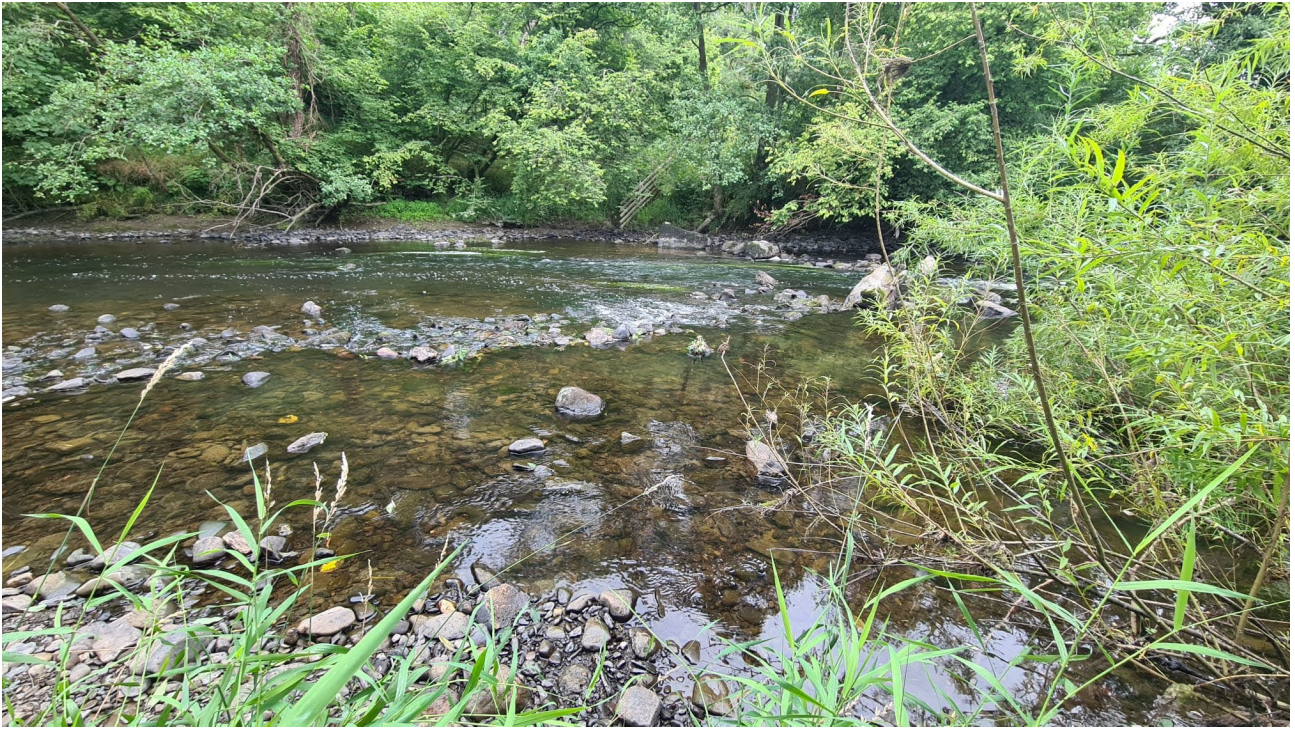
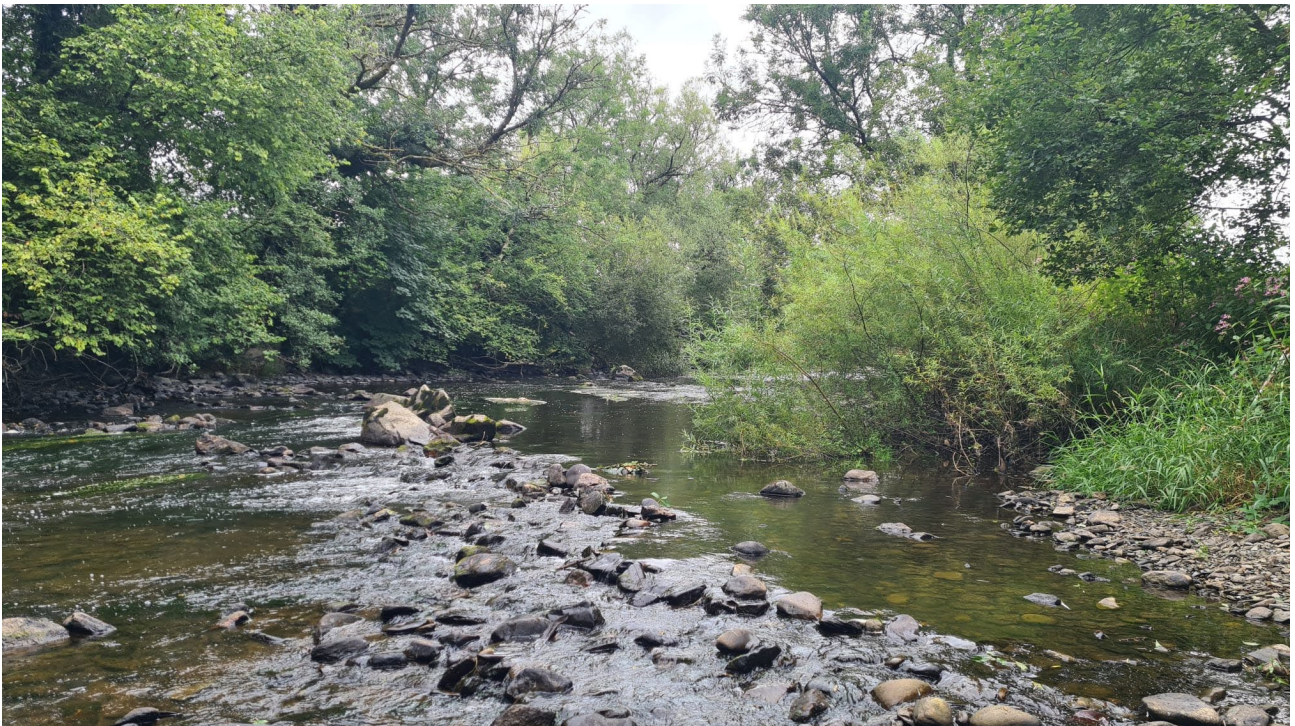
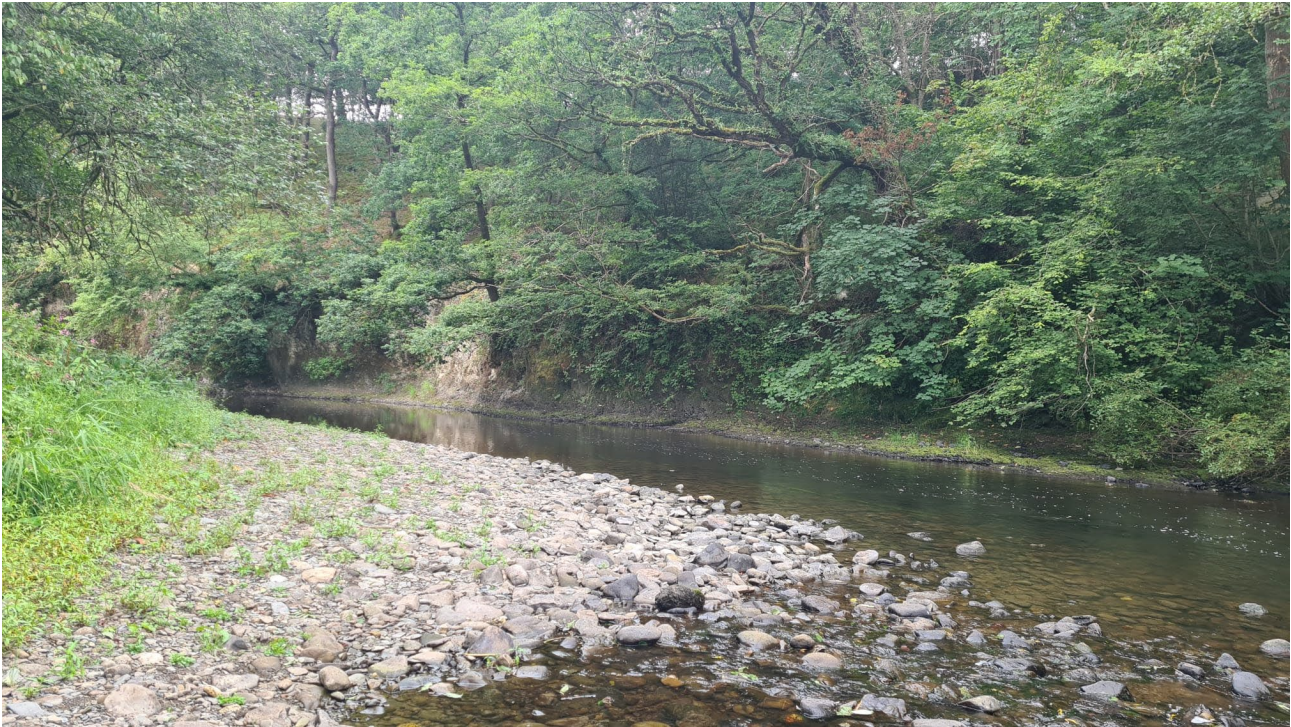
In the RHS survey length, the right bank was steep and wooded, and there was a caravan site along most of the left bank. Artificial features noted were a major bridge and a major deflector, but no artificial bank was noted other than poaching of both banks. Impacts include agriculture and the presence of the caravan site, with moving of the left bank noted as recent management. The caravan site manager informed us that there were otters along this section of bank but none were seen on this visit. Himalayan balsam was present on both the bank face and the bank top. The HMS class was 3, mainly due to the presence of the caravan park on its banks.

Figure 29. Photo of Ithon, Disserth, at the midpoint across the channel

Figure 30. Photo of Ithon, Disserth, at the midpoint facing upstream

Figure 31. Photo of Ithon, Dissersh, at the midpoint facing downstream

The surrounding land is used for grazing sheep, the presence of poor improved grassland and amenity and improved grassland meant the simplified phase one score was moderate despite the presence of broad-leaved woodland on the right bank. Recommendations for this site include control of the Himalayan balsam and creation of a buffer strip within the caravan park where caravans and their decks are sited right up to the bank top in places. Control of the invasive Himalayan balsam is also recommended at this site.

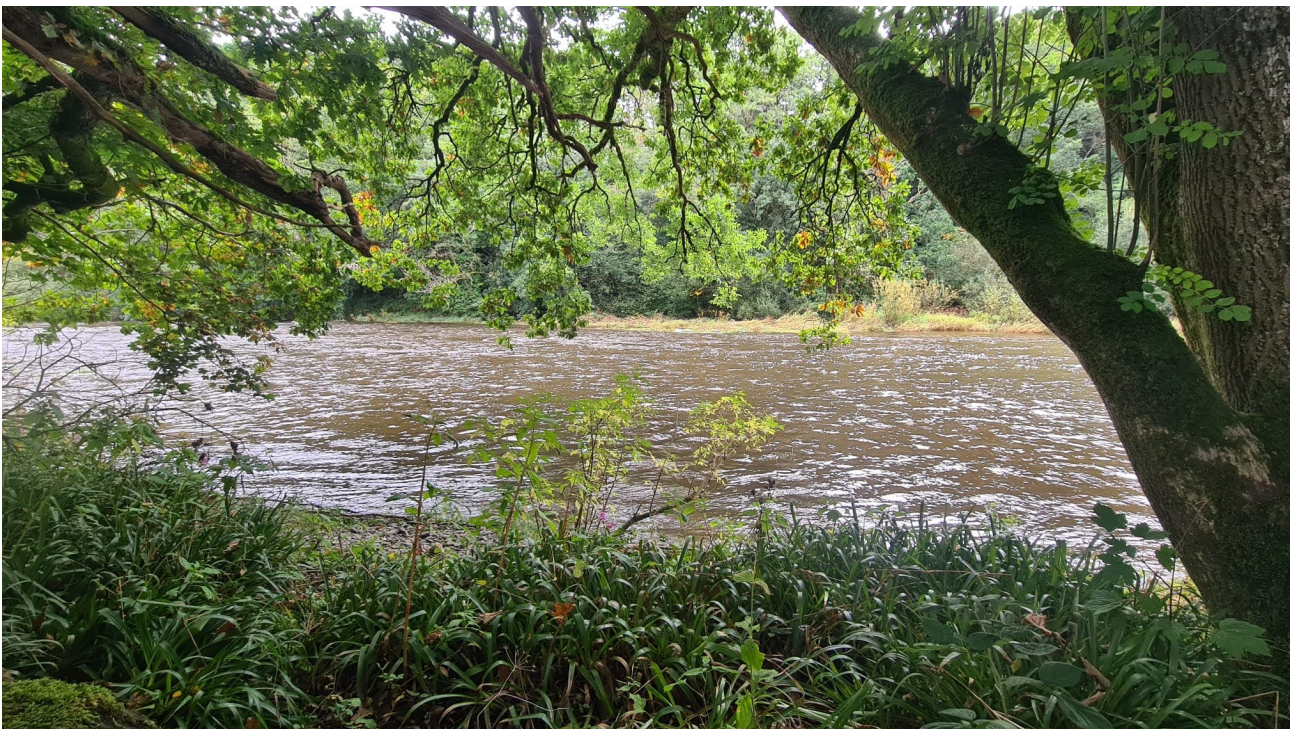
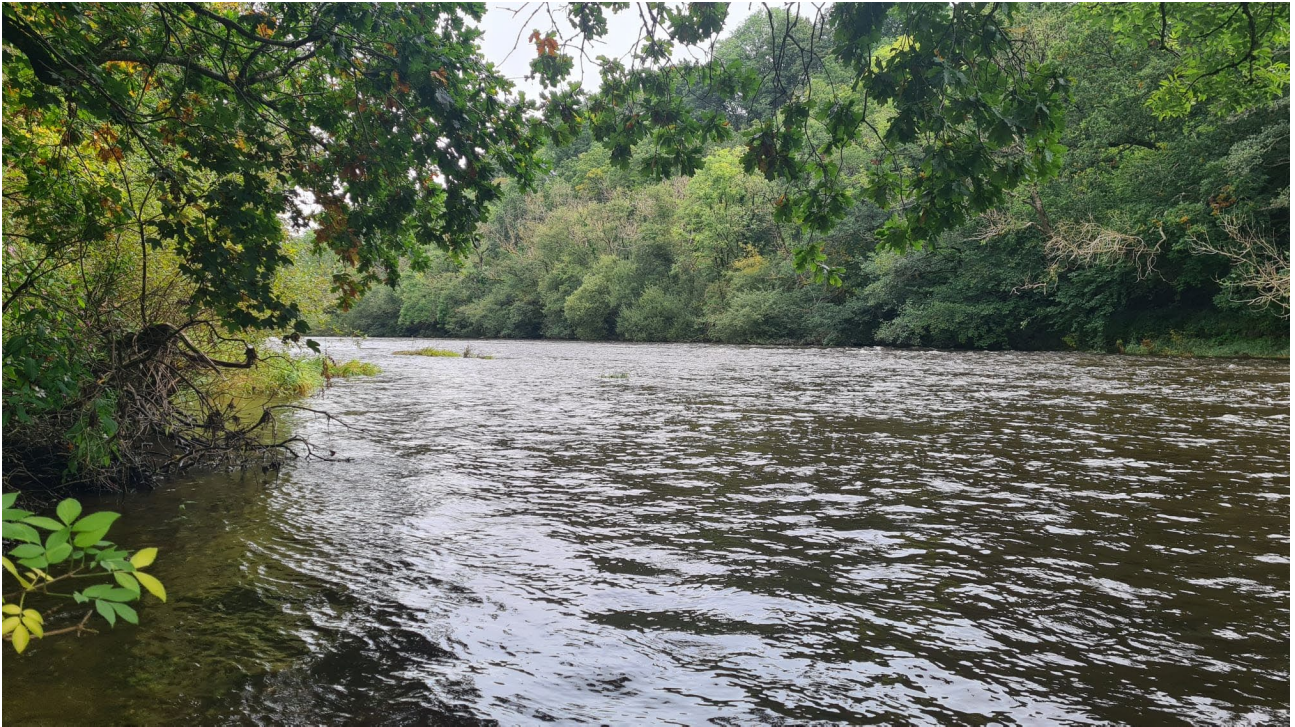
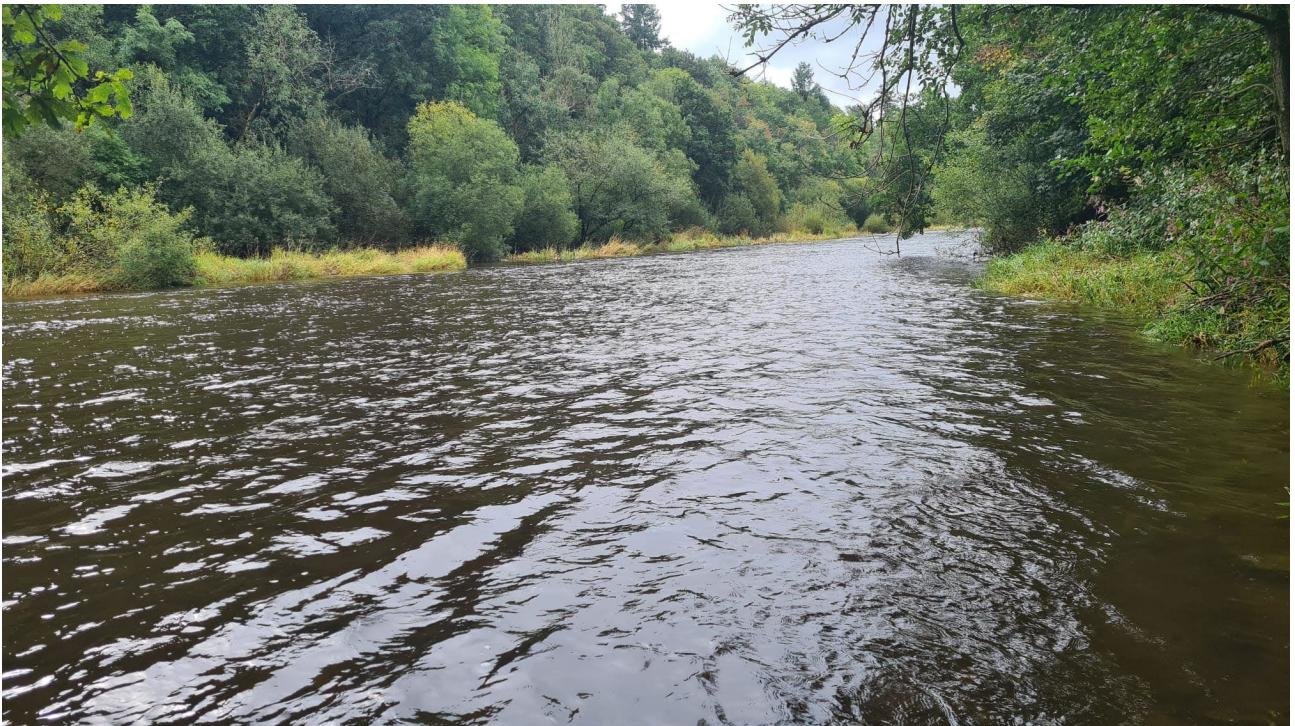
In the 500 m RHS, there were no artificial features present, and the left bank was largely unmodified other than some localized re-sectioning, but the right bank had extensive re-sectioning and had some poaching. There was a vegetated sidebar along most of the right bank. The HMS class was 3. The alien invasive species Himalayan balsam was present on the bank face.

Figure 32. Photo of Wye, confl Ithon, at the midpoint across the channel

Figure 33. Photo of Wye, confl Ithon, at the midpoint facing upstream

Figure 34. Photo of Wye, confl Ithon, at the midpoint facing downstream

Despite the broadleaved woodland which scores highly present on the left bank, the SERCON score was only 3, the middle category of the simplified phase one habitat survey due to the dominance of poor semi-improved grassland on the right bank with arable land behind a footpath and narrow strip of hazel trees on the bank face. The surrounding land use was agricultural with crops and sheep grazing. Recommendations for this site include control of the invasive Himalayan balsam and creation of a wider buffer strip along the bank top where appropriate.

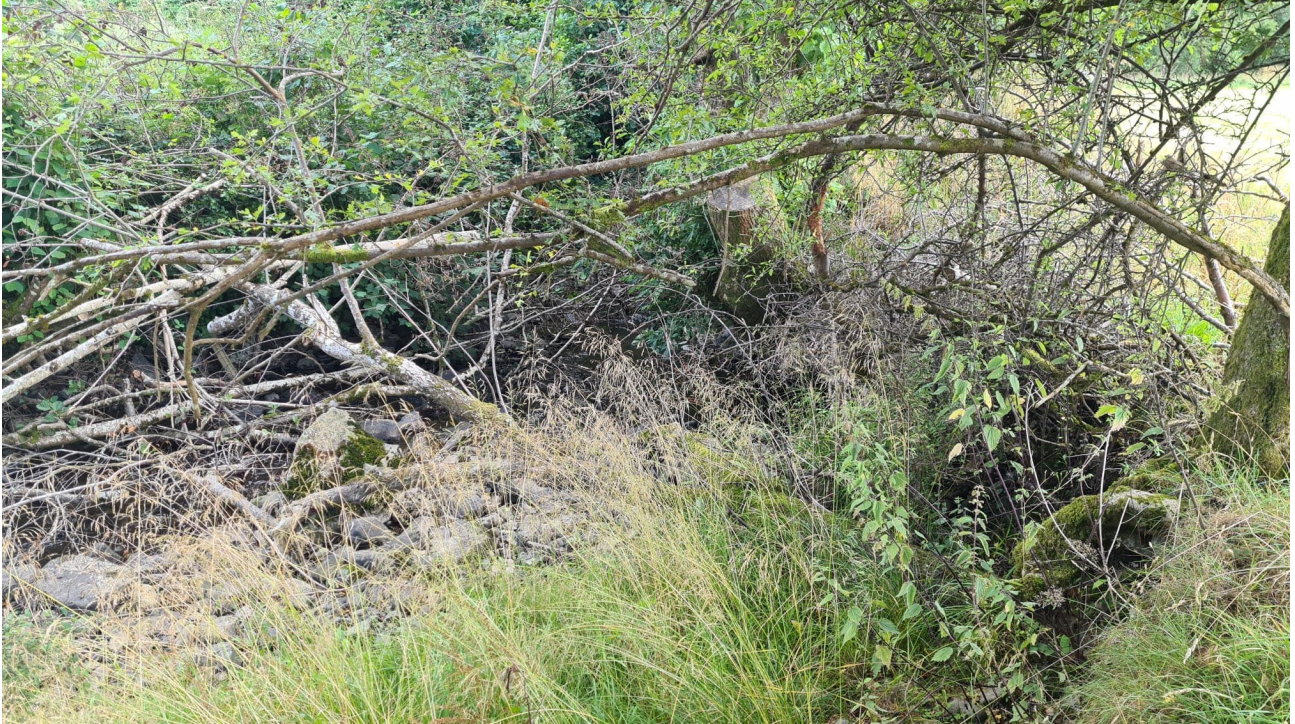
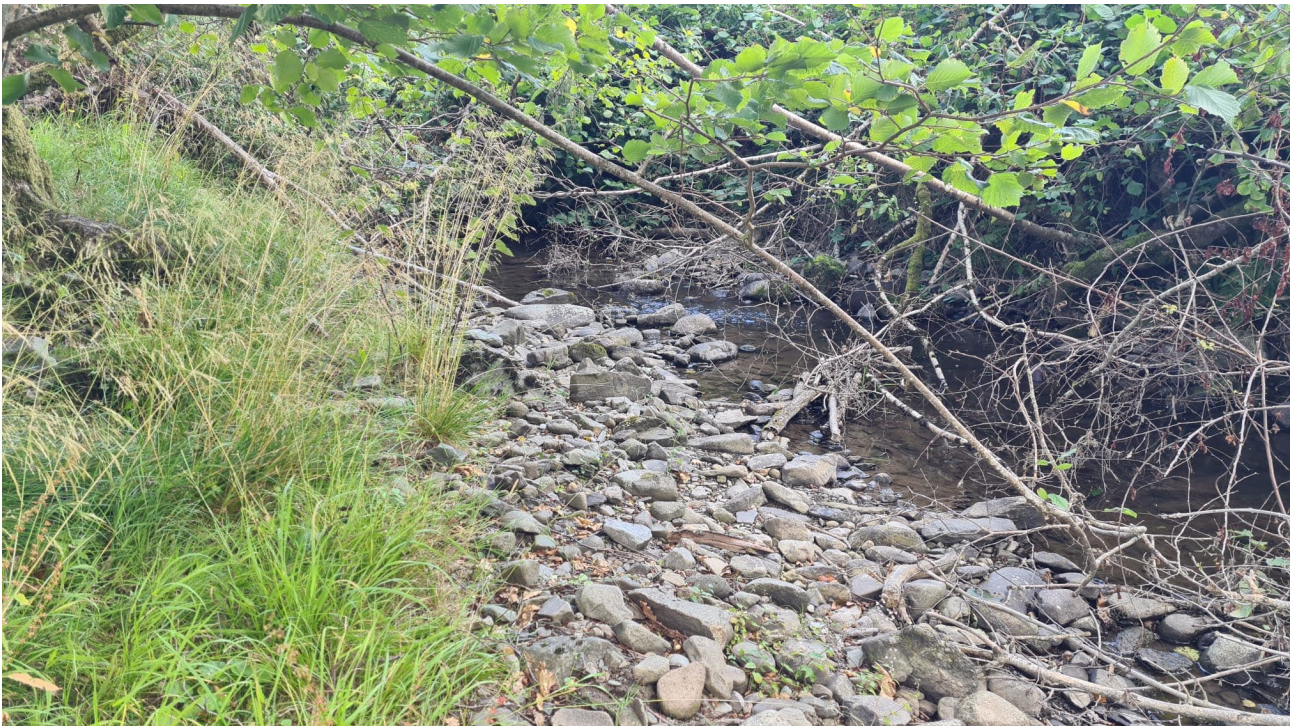
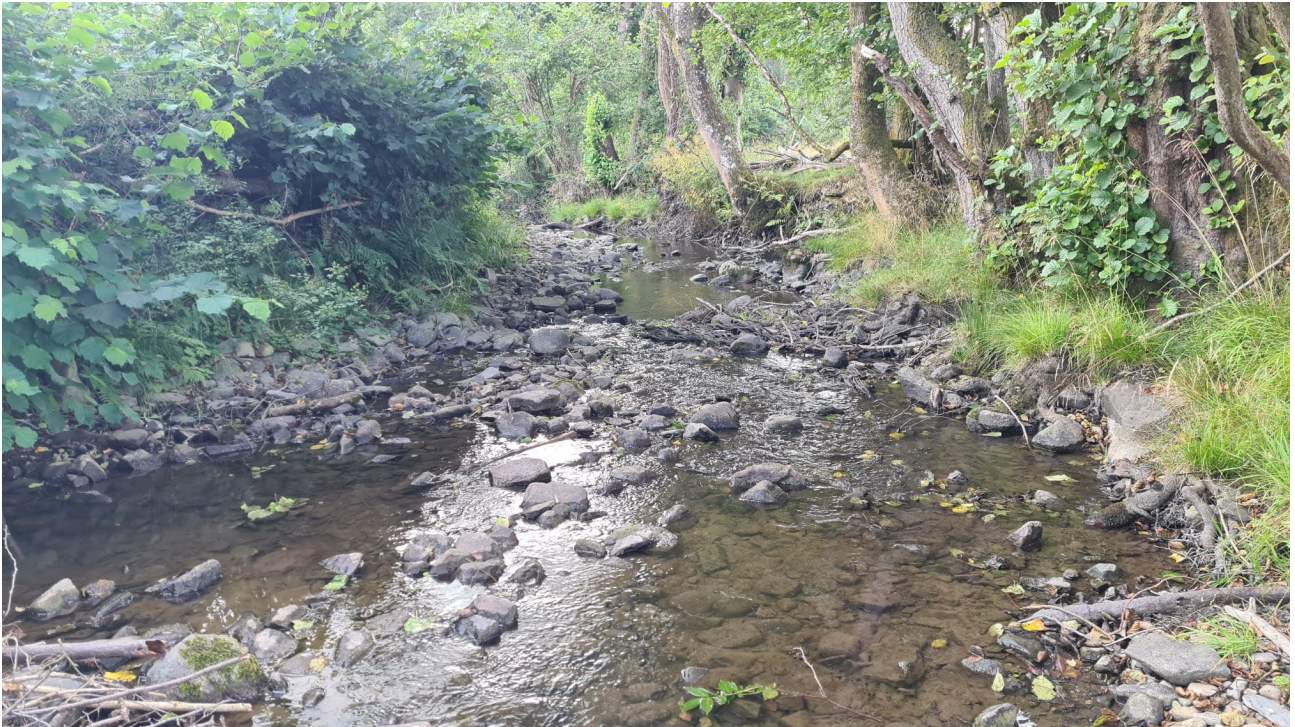
In the RHS survey, artificial features included a minor bridge, a minor weir and a ford. There was some localized bank re-sectioning noted, an area of embankment, and poaching of the banks was recorded, with bare bank in places, but most of the bank was considered to be natural with various features including stable and eroding cliffs, sidebars and point bars. The HMS class was 3, mainly due to the artificial features recorded.

Figure 35. Photo of Dulas Brook, Cwmbach, at the midpoint across the channel

Figure 36. Photo of Dulas Brook, Cwmbach, at the midpoint facing upstream

Figure 37. Photo of Dulas Brook, Cwmbach, at the midpoint facing downstream

The surrounding land is used for agriculture, and the presence of poor improved grassland and some bracken meant the simplified phase one score was moderate despite the presence of broad-leaved woodland. Fencing in places, set away from the bank top to allow a natural strip of vegetation would reduce the bank poaching, and maybe also reduce the siltation seen in the channel.

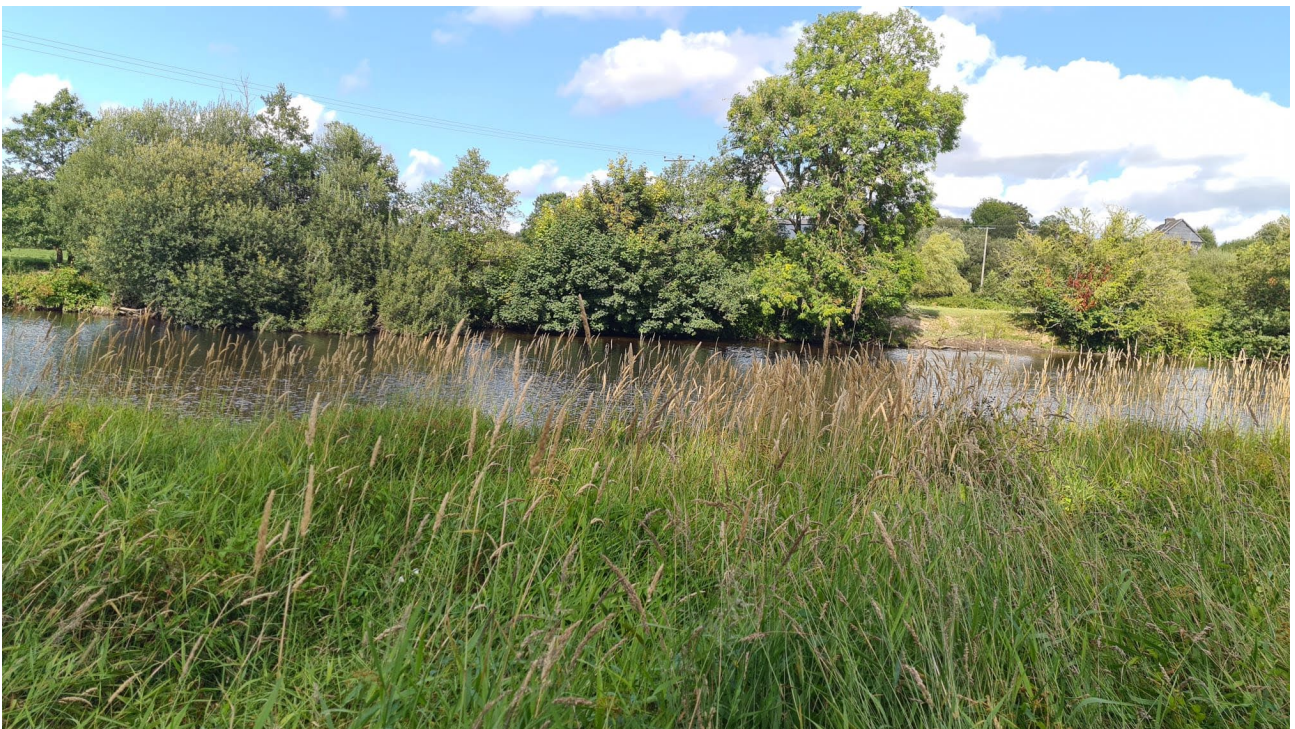
In the 500 m River Habitat Survey length, 50 % or more of both banks had been re-sectioning and embankment was extensive on the left bank. At the midpoint, there was a berm along the right bank. Trees were fairly continuous on both bank faces except for the upstream section of the right bank where trees were regularly spaced on the bank top. Poaching was present on both banks. Both bank tops were predominately improved, and amenity grassland and the surrounding land was used for sheep grazing. Himalayan balsam was present on the bank face and the bank top. The HMS class was 3 due mainly to re-sectioning and embankment on part of the left bank. Historic re-sectioning on the right bank was not included as it was considered to be becoming naturalised.

Figure 38. Photo of Wye, Builth Rd, at the midpoint across the channel

This site is therefore impacted by agricultural use, historic bank re-sectioning and embankment. Recommendations at this site are to control the invasive Himalayan balsam and allow the re-sectioned banks to degenerate naturally, or reprofile to a more natural shape as appropriate. As mentioned at other sites, fencing should ideally be set back away from the bank top to allow more natural vegetation to create a buffer strip.
